# Bank of Alexandria

## Façade Assessment

1200AE PROJECT NO. 19-029

July 29, 2019

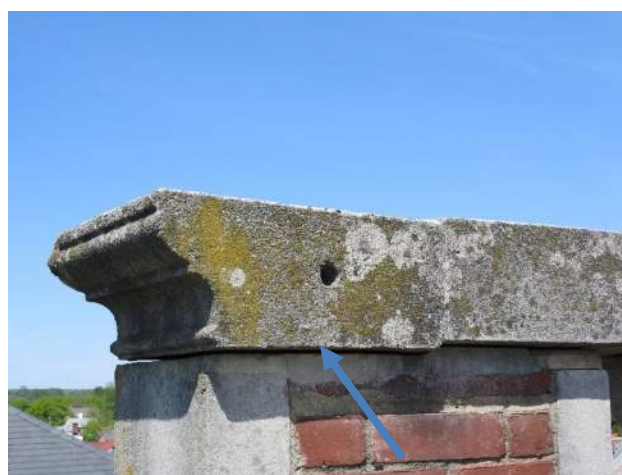
Currently, the concrete rail has large areas of staining and biological growth. At the southern end of the west façade balustrade, two railing stones have shifted inward, away from the wall face, with 1-1/4" movement noted at the southern end (Figure 13). Based on observations, the cramp detail has failed, likely due to corrosion (Figure 14). In this area, visible separation exists between individual balusters and rail elements.

Figure 13: Rotation of concrete coping away from west elevation.

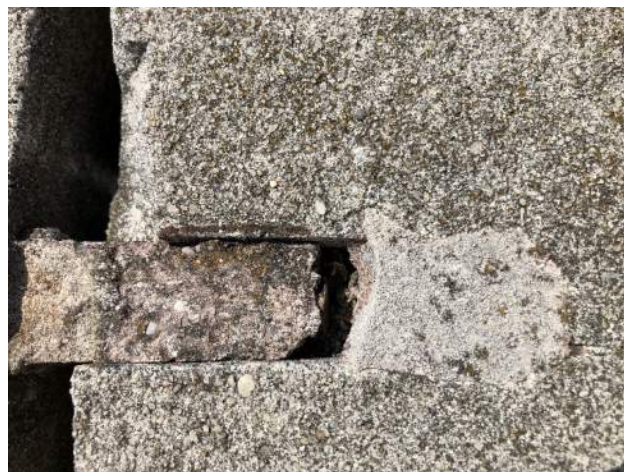
Figure 14: Failed crimp and separation between rail stones at west elevation.

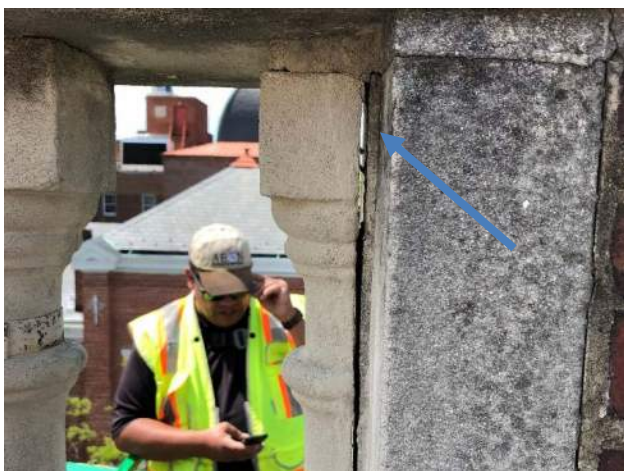
Several of the balusters are loose and can be easily moved by hand (Figure 15). The paired elements forming the individual balusters are generally held in place via a metal crimp attached to the upper and lower portions of the baluster (Figure 12, above), which was likely added as part of the original installation of this concrete assembly, once deterioration caused separation between baluster faces. These crimps generally exhibit superficial corrosion, and some are loose. More than thirty of the balusters show signs of cracking and separation of the paired elements. Most of the observed cracking in the balusters would be considered significant – with more than half those observed exhibiting deep cracking and separation or spalled concrete (Figure 16 and Figure 17). Generally, where able to be observed, the existing interior metal rods are corroded with significant section loss.

Figure 15: Separation of loose half baluster.

Loose baluster elements should be removed or stabilized in place in order to minimize falling hazards to the street level.

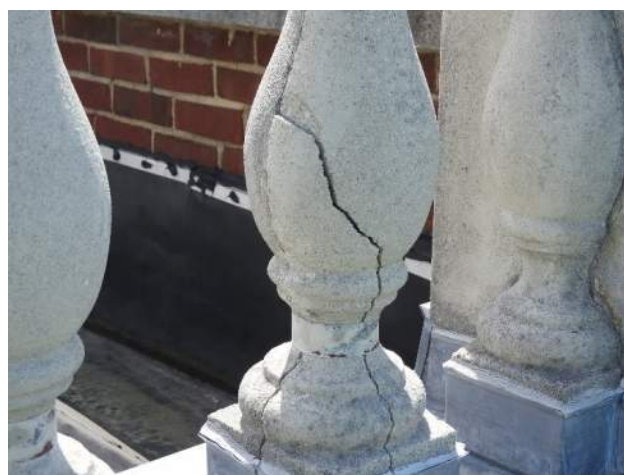
It is likely that the observed cracking in the individual balusters are the result of two main mechanisms occurring in this area. As noted above, a thin joint joins the two halves of the baluster together. This seam appears only partially grouted, allowing water infiltration into the baluster assembly. Additionally, based on observations, the embedded rods in the baluster halves have a very small amount of cover protecting them at both areas of necking (thinning of the baluster) and at the interior joint (Figure 19). The lack of sufficient cover allows for increased opportunity for cracking and spalls, particularly under freeze thaw cycles.

Figure 16: Typical cracking in baluster.

The balusters and associated connecting elements should be individually repaired or replaced, as required based on the existing condition. Replacement balusters should be detailed with a mechanical attachment to the base of the balustrade assembly. It should be assumed that baluster elements require replacement, in order to remove existing deteriorated and corroded portions of the existing balustrade assembly. This will require removal and replacement of the existing flashing details at the balustrade.

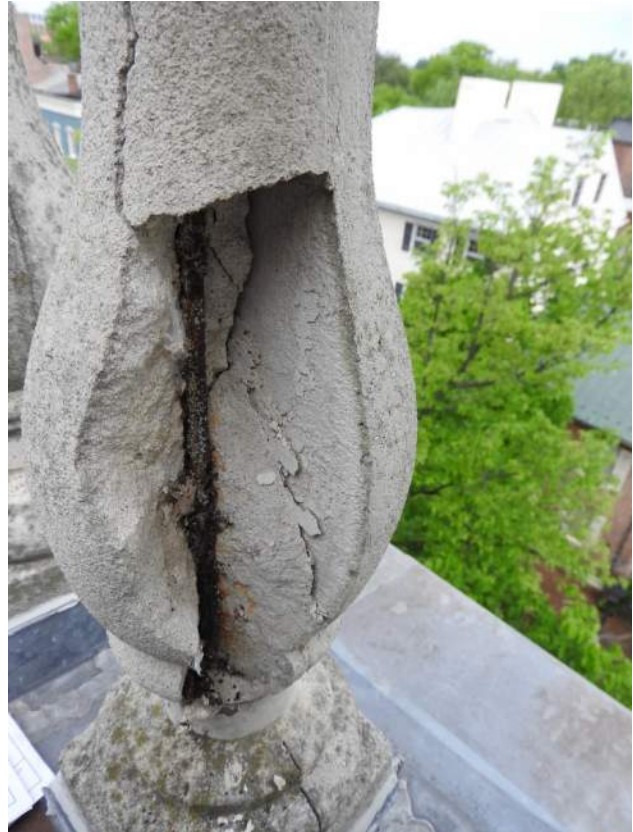
Figure 17: Spall at baluster exposing interior metal rod.

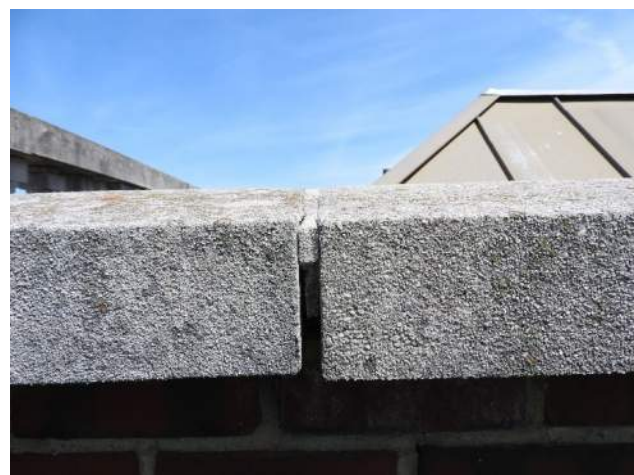
At remaining areas of the roof, the brick masonry is capped by a cast concrete coping stone. Generally, the concrete appears to be in fair condition, with surface staining, biological growth, and loss of mortar at joints (Figure 20).

Figure 19: Loose, missing mortar, in existing coping joint.

Open joints should be repointed with an appropriate mortar.

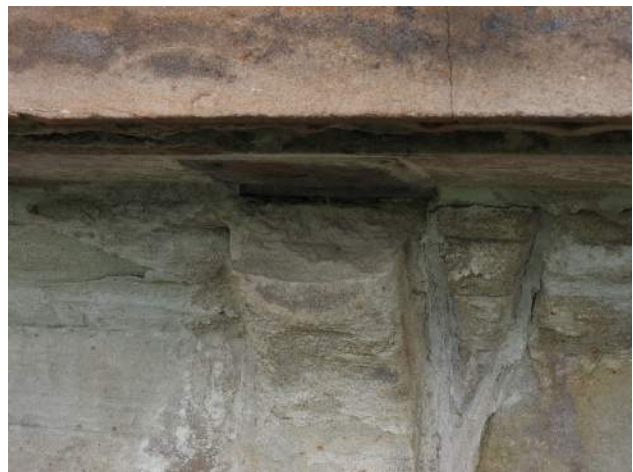
Generally, the stone is in poor condition, with large areas of section loss, stone exfoliation, staining, weathering, and stone spalling (Figure 23 and Figure 24). Areas of the stonework exhibit signs of efflorescence, salt deposits left behind on the surface of the stone from water. Large portions of the frieze and cornice have lost architectural detailing due to these sources of deterioration. When sounded, portions of the cornice and frieze detail are hollow or unsound, which indicates that there is section loss behind the exterior face of the stone. Some areas of

Figure 23: Loss of bracket, signs of exfoliation, and past patching efforts at bracket location.

Loose material and spalls should be removed from the surface of the stone, including surface contaminants such as salts, or stabilized in place. The removal process should include comprehensive sounding to assure delaminating stone material is not left in place. Remaining stone should be dressed to allow water to shed from the surface. Dressing refers to the process of working or shaping stone into a desired shape.

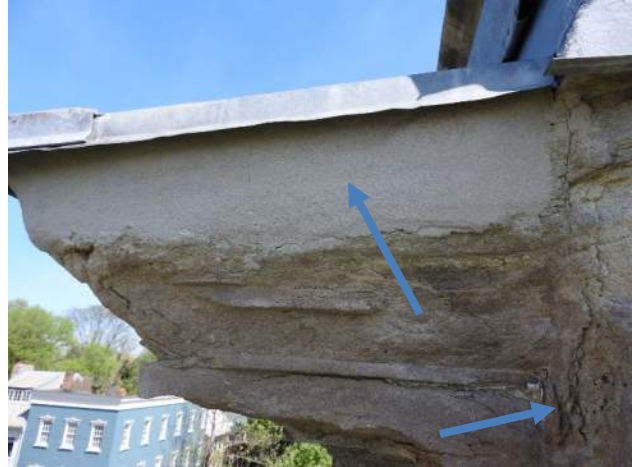
Figure 24: Stone flaking and past patching efforts at southwest cornice detail.

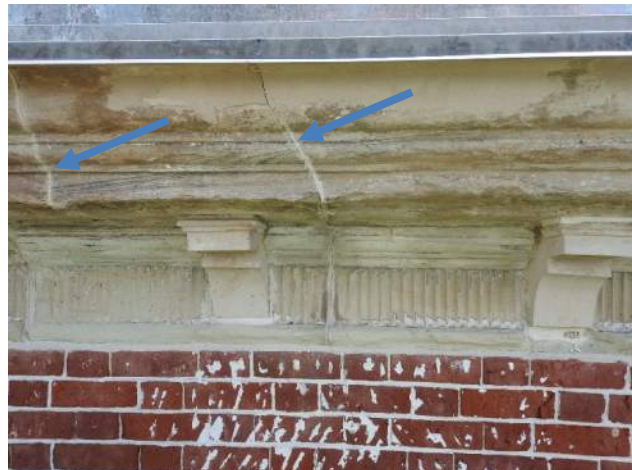
Figure 26: Stone with open cracks and cracks with some evidence of past repointing.

Existing open cracks should be repaired and repointed with an appropriate mortar.

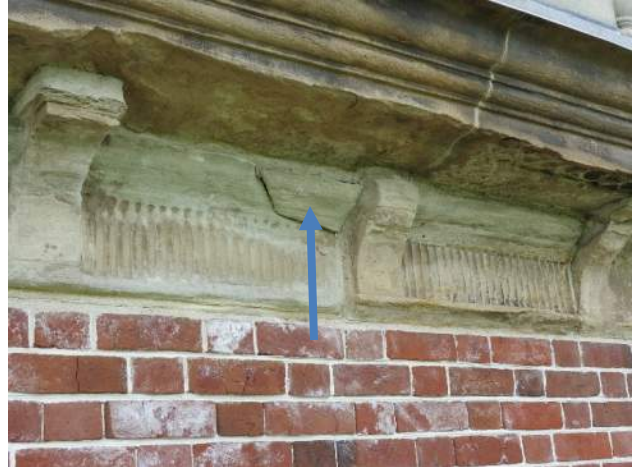
At the north elevation, discrete areas of the stone cornice and frieze were noted to be loose (Figure 27). In three areas of the north elevation, loose stone was removed from the building in order to limit falling hazards (Figure 21 and Figure 28). These locations are noted in S301 in Appendix A. Where material was removed from the stone detailing, the historic metal anchors were observed to be corroded, with significant cross-sectional loss (Figure 21, above). The remaining stone in areas of removal had damp feeling surfaces, indicating that water infiltrates the stone detailing, either through gaps in the existing flashing or by infiltrating through the stone, roof, or wall surfaces. Remnants of stone removed from the structure were given to the Owner.

Figure 27: Loose stone at north frieze detail noted prior to removal.

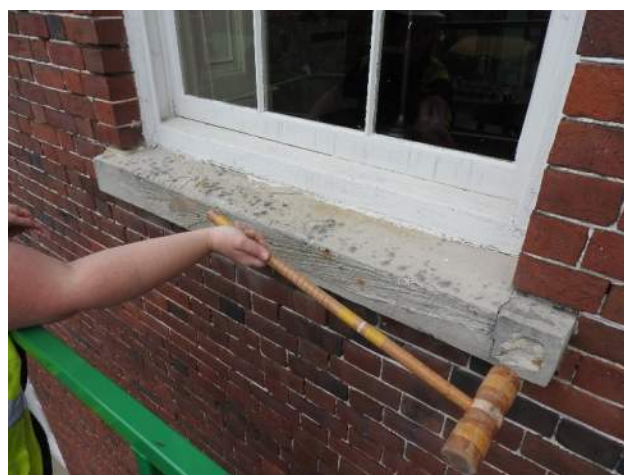
When sounded, most of the stone and surrounding patch appears hollow or unsound (Figure 31). On observation, many of the patches on existing lintels appear to be failing. There is evidence of cracking, generally on the underside of lintels (Figure 32), but also on the face of

Figure 31: Sounding stone and patches at existing sill. Cracking in sill at edge of patching material.

Hollow sounding stone and patches should be resounded and removed if deemed likely to fail again in the near future.

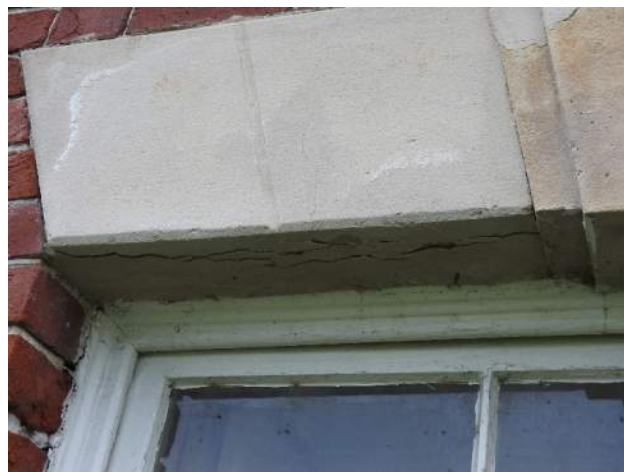
Figure 32: Cracking at underside of patched stone lintel.

Existing open cracks should be repaired and repointed with an appropriate mortar.

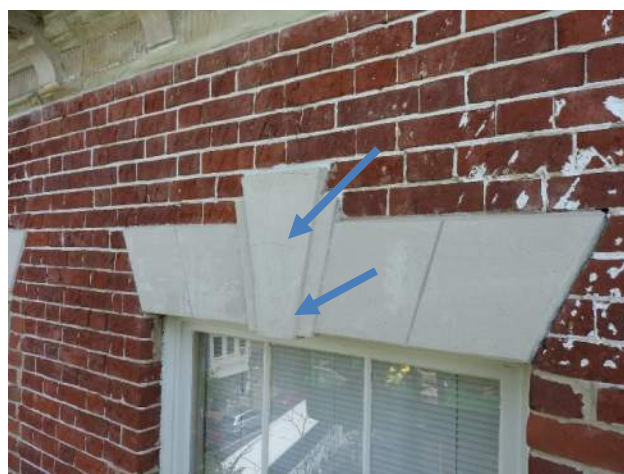
some lintels (Figure 33). It is possible that these cracks are opening at previous areas of disrepair which the patching material covered over. Some spalling of the patching material, stone, and concrete was observed, particularly on the north elevation. Several sills and some lintels at the north elevation were observed to have surface staining or biological growth (Figure 34).

Figure 33: Cracking at face of patched stone lintel.

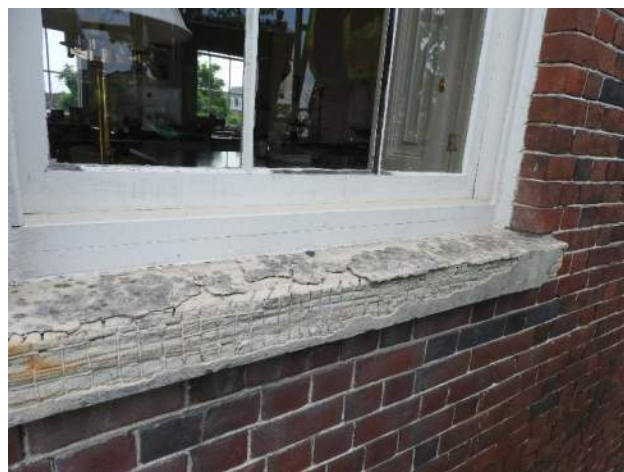
Figure 34: Surface staining and failing patching at stone lintel.

Loose material and spalls should be removed from the surface of the stone, including surface contaminants such as salts or stabilized in place.

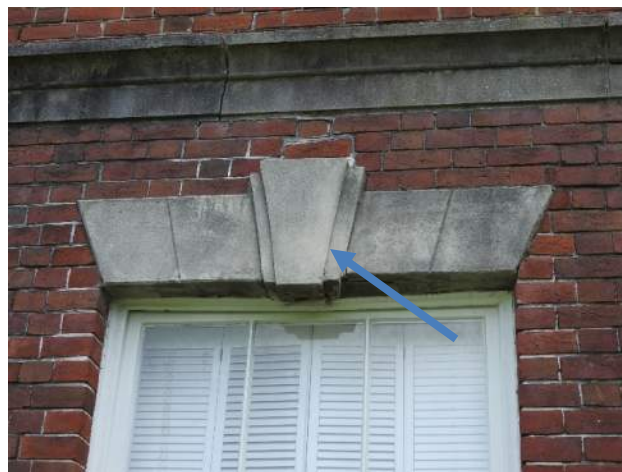
At multiple locations, the keystone of the original stone lintel was observed to have slipped downward (Figure 35). This likely did not occur recently as a caulk patch material was observed in brickwork above the stone lintel. This observed movement minimizes the ability of the stone elements to properly support the load above over the existing opening by altering how the individual stones work together as a lintel element. Over time, this can affect the existing window or door frame by transferring loads directly into the frame where the lintel is unable to carry loads to adjacent masonry construction. Some evidence of this was observed, with localized crushing of wood window frame elements.

Figure 35: Slipped keystone in stone lintel on north elevation.

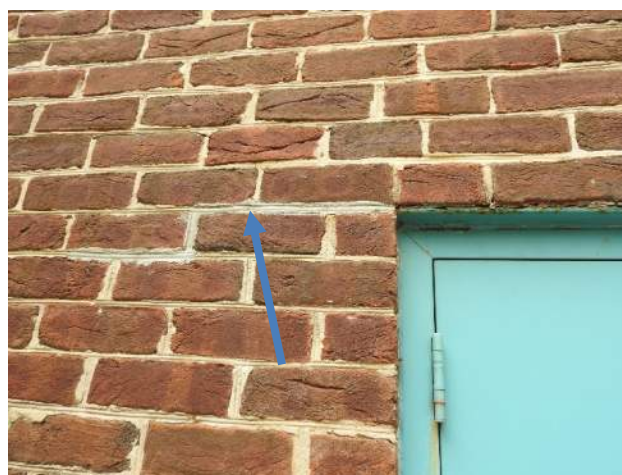
Figure 37: Recent repointing at steel lintel bearing, indicating rust jacking.

At the basement level opening to the southeast addition at the east elevation, the existing steel lintel shows signs of rust jacking and previous masonry repair (Figure 37). Rust jacking occurs when steel lintels expand as a result of corrosion, which results in uplifting or jacking the surrounding masonry. This is typically most evident at bearing ends of the steel lintel, which would have cracking and other signs of distress in the masonry construction.

The existing steel lintel at the basement entry should be cleaned and repainted with a rust inhibiting paint.

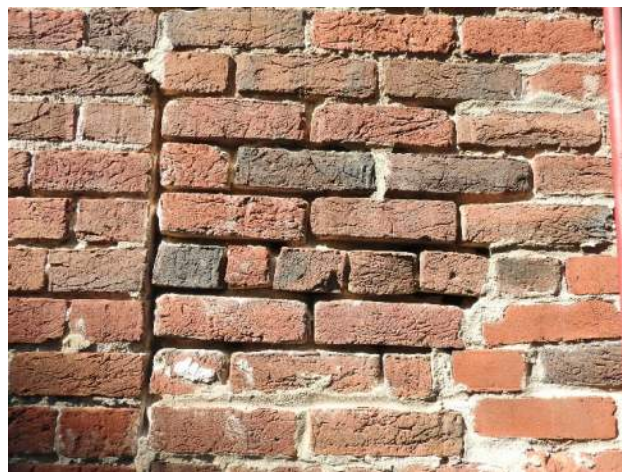
Figure 39: Area of masonry construction with open mortar joints.

Existing masonry should be cleaned and repointed with an appropriate mortar, compatible with the historic brick units. Existing cracks should be cleaned and pointed. Once repaired, cracks should be visually monitored for signs of recurring movement.

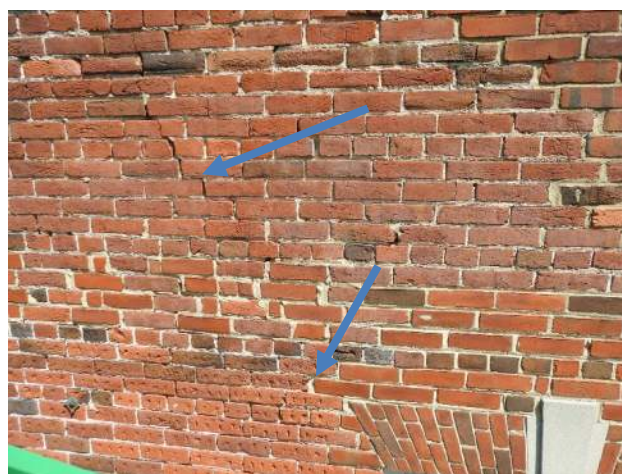
Figure 40: Existing cracking above window opening at south elevation.

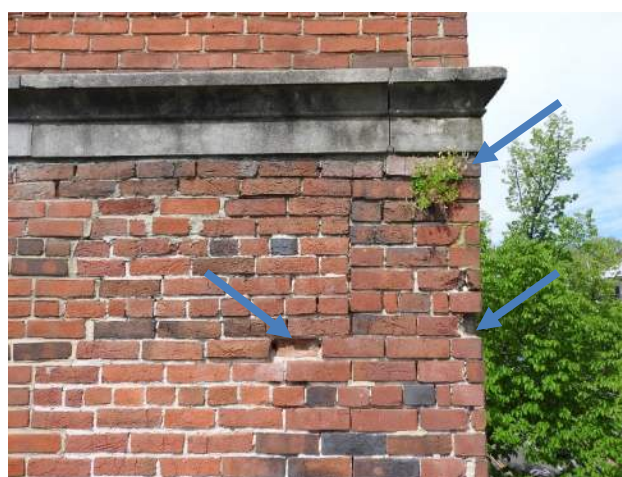
Where able to be observed in detail, the brick appears to be in relatively good repair, although localized areas of deterioration were noted. Observed deterioration is primarily in the form of open mortar joints, with large zones of mortar loss observed on the north elevation and more concentrated areas observed on the remaining elevations (Figure 39). Localized cracking was observed in the brick masonry at all elevations (Figure 40) and at the backside of the existing chimney construction, as observed from the roof. Some of this cracking appears to correlate with the perimeter of reconstructed brick at the south and east elevations. Locally, some bricks were spalled, loose, or missing, and some areas of active biological growth were noted (Figure 41). At one area of

Figure 41: Spalled, missing bricks, and active biological growth.

Spalled and missing bricks should be removed and replaced with appropriate replacement bricks or stabilized in place.

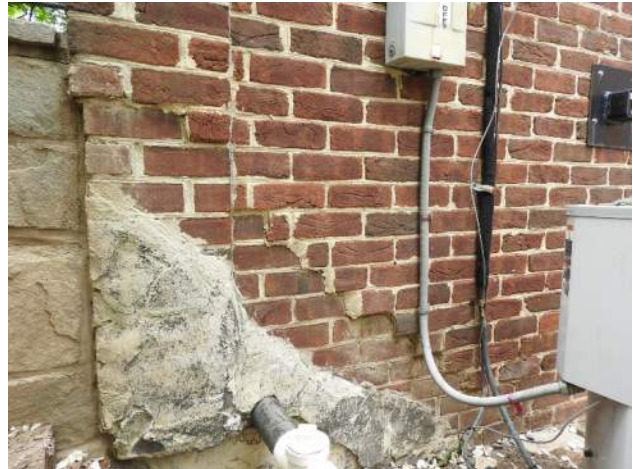
Figure 42: Separation in existing brick construction.

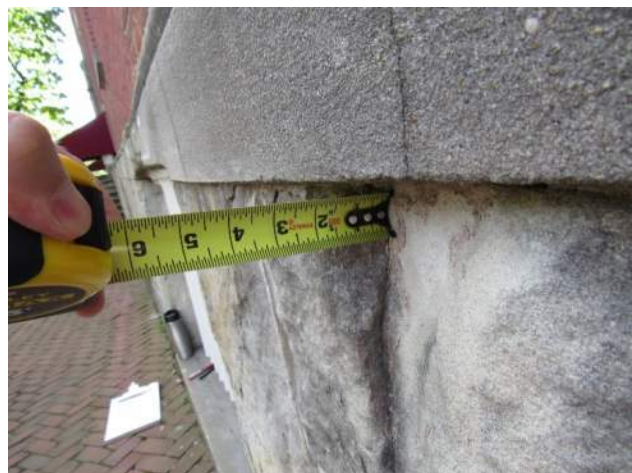
Figure 45: Existing spall at north face.

Loose material and spalls should be removed from the surface of the stone, including surface contaminants such as

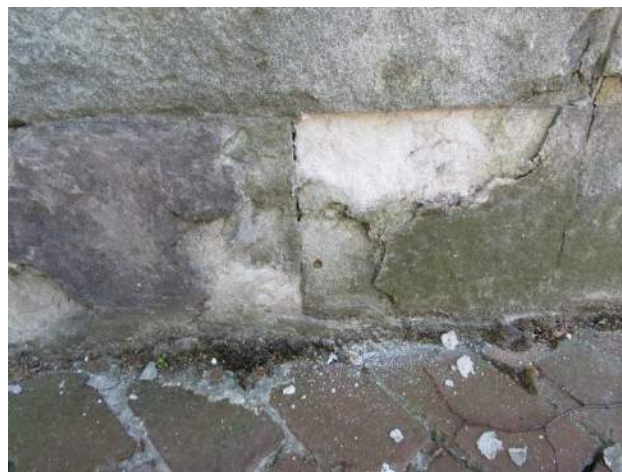
Figure 46: Flaking face of stonework.

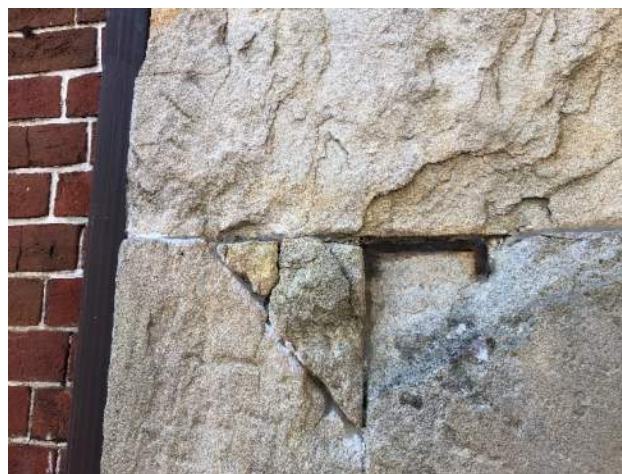
Figure 47: Spall at embedded iron tie.

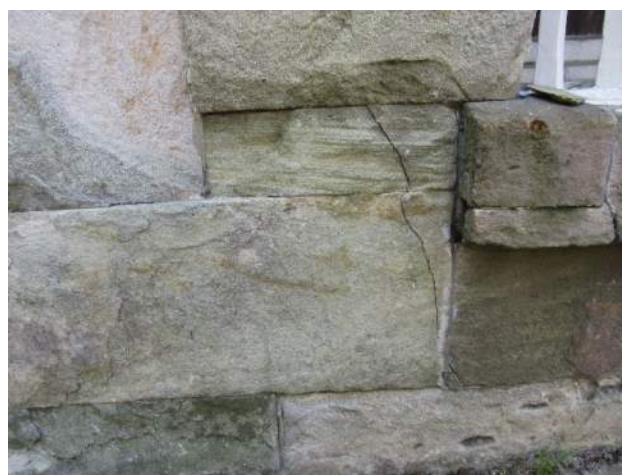
Generally, the existing mortar joints appear to be open. There are many areas of existing cracks in the stonework (Figure 48). Some of the cracks and joints have been infilled with a caulking or sealant. Cracking allows for water penetration into the stone. This, in conjunction with freeze-thaw cycles and the corrosion of embedded anchors noted above, causes the observed spalling in the stone. An additional contributing factor to the deterioration is the salt deposits on the masonry construction – such deposits were observed up to seven feet from grade, which is generally above the stone coursing. Large areas of stonework were observed to have surface staining from biological growth or other deposits (Figure 49).

Figure 48: Cracking in stonework.

Existing masonry should be cleaned and repointed with an appropriate mortar. Existing cracks should be cleaned and pointed.

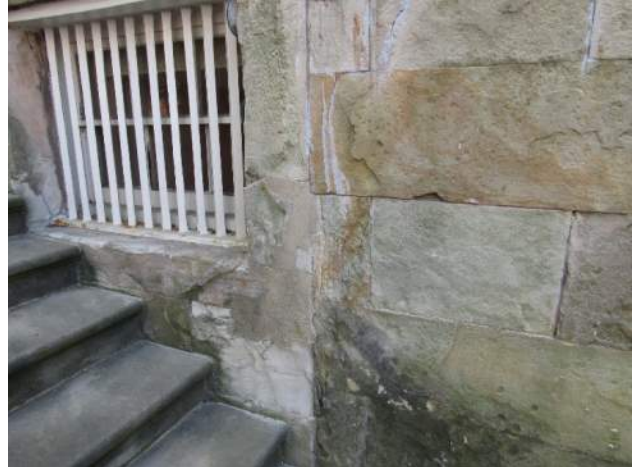
Figure 49: Surface staining from biological growth and previously caulked joints.

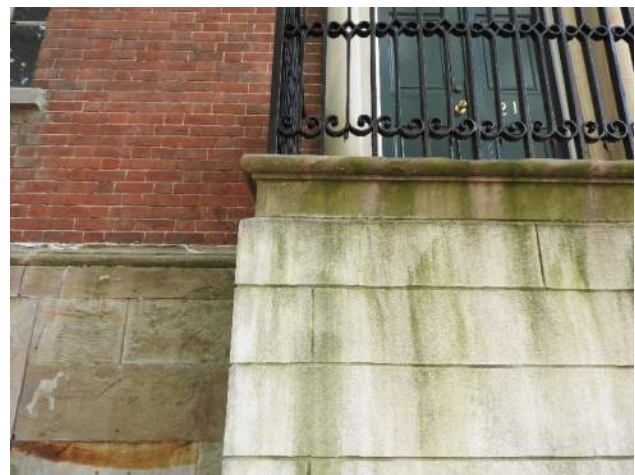
Figure 53: Typical surface staining at stair.

Loose material and spalls should be removed from the surface of the stone, including surface contaminants such as salts, or stabilized in place. Remaining stone should be dressed to allow water to shed from the surface.

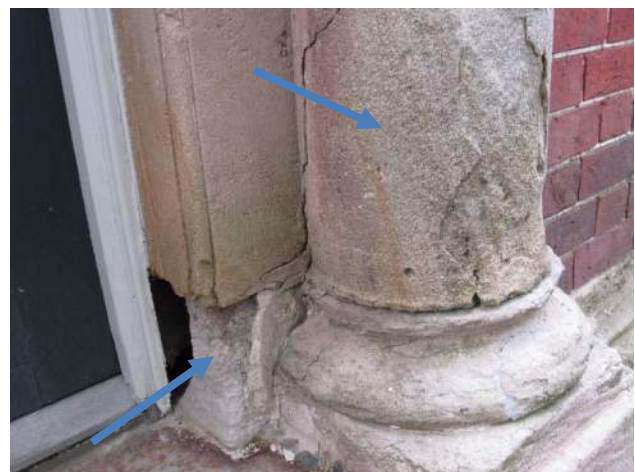
Cracking is present in the face of the stucco parging and throughout the exposed stone surrounds. It is possible that cracking observed in the stucco parging (Figure 52) mimics preexisting or new cracks in the stonework beneath. Biological growth and staining exist at both the stair construction and the stone surrounds (Figure 53). The stone at the door surrounds, particularly at the north entry, is significantly deteriorated, with large areas exhibiting section loss in the form of spalls and flaking (Figure 54).

Figure 54: Stone deterioration at north stone surround.

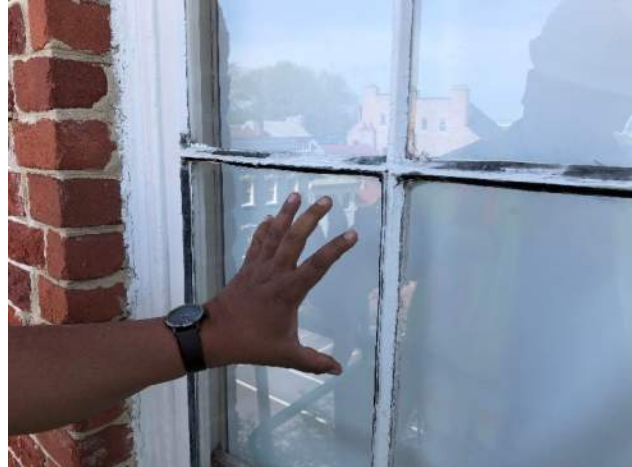
The existing windows at the original structure generally consist of a 6-pane over 6-pane double-hung wood framed window. Typically, window muntins were observed to have evidence of past epoxy repair, surface staining, and mold growth, particularly at the north and west elevations (Figure 55). Wood window frame elements were observed to have section loss, rot, and other signs of wood deterioration which has been largely obscured by existing paint. Individual panes of glass were observed to be loose or cracked, with some removed for installation of exterior mounted cooling systems.

Figure 55: Loose windowpane, muntins with mold growth.

A detailed survey of the existing windows and window frames should be completed by an architect or architectural conservator, in order to better document and understand the extent of deterioration to these elements and to recommend specific repair or replacement methods.

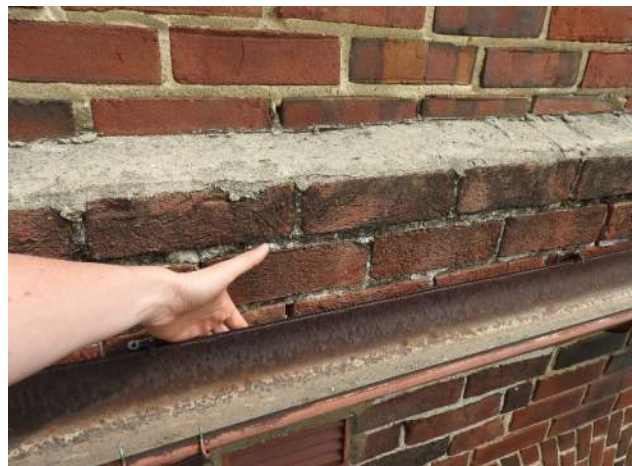
Figure 57: Observed gap at roof terrace gutter system.

Existing waterproofing membranes at the rooftop terrace and grade level terrace should be examined to ensure that there are no existing openings or other opportunity for leaks which allow water infiltration to interior spaces. 1200AE recommends this be reviewed by an architect or exterior envelope specialist, perhaps in coordination with the recommended window assessment.
