BULL RUN OCCOQUAN TRAIL

TRAIL ASSESSMENT REPORT

2018

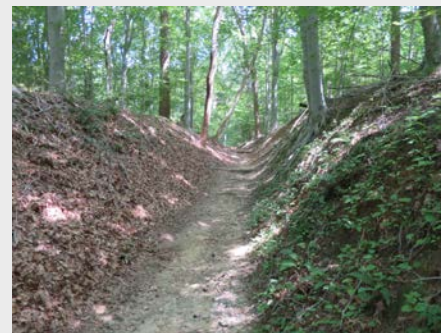
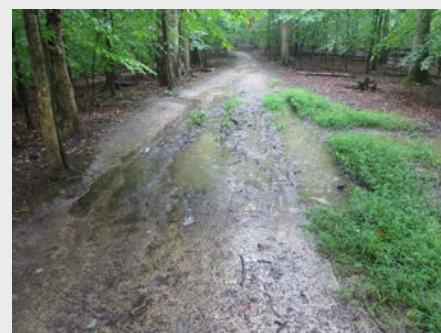
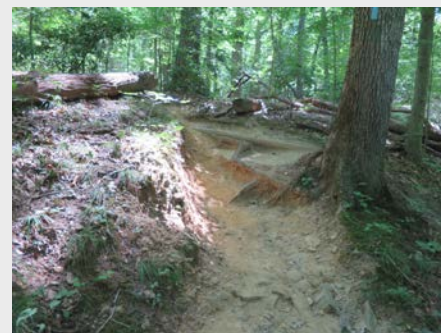
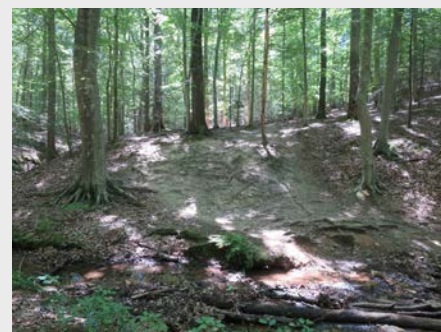
Hydrology is the dominant natural process effecting the BROT. In upland landscape locations where the trail has often been routed on historic road beds that have compacted with use to a subgrade condition (top photo), water cannot be moved from the trail tread and subsequent erosion and/or wet/muddy conditions ensue. In lower landscape positions where groundwater tables are seasonally close to the ground surface, trail routing in flat areas results in tread compaction, prolonged muddiness, and trail widening/braiding (2nd from top photo).

The informally hiked-in connectors between upland and lowland historic roads have been developed with alignments that run on or near the steepest path down the landscape. This fall-aligned location does not allow water to be managed off the trail. Without a steeper path of runoff available, erosion begins and results in a subgrade trail condition that further focuses runoff within the trail tread. This process exposes roots and rocks in the trail (2nd photo from bottom) and deposit sediments within stream valleys. Trail users attempt to avoid these areas that are harder to negotiate, widening the trail and further exacerbating the erosion issues (bottom photo).

There is no effective maintenance for fall-aligned trails. Rolling, contour-aligned relocations are necessary to mitigate resource damage and provide a durable trail tread that will meet the use type and volumes that are currently present on the BROT. Eroded trails should be restored to provide natural hydrology or natural resource degradation will continue.

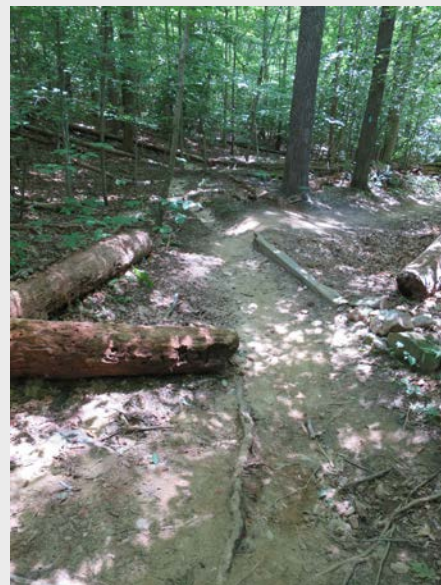
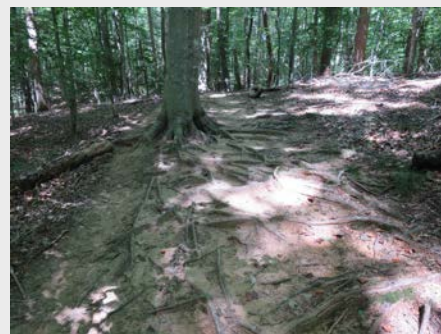
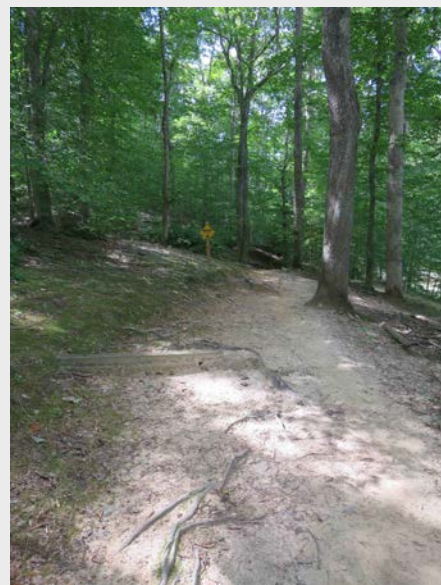
Most of the impact that is present revolves around visitors avoiding obstacles or muddy conditions in the trail tread. The informally routed trail only laterally confines trail use width where there are historic berms on the sides of compacted/eroded road beds. Where trails have been hiked in, there is no width confinement and trail users have trampled widening paths when they encounter obstacles such as roots, rocks, water bars (which further reduces the utility of these structures), or muddy conditions. Eventually, some trees will be permanently damaged as their root structures are undermined. Additionally, the trail widening and braiding, along with the historic road routing, reduces the backcountry feeling of the BROT. Redeveloping eroding sections as relatively narrow, contour-aligned routes will confine use to the trail tread and improve the trail's intended backcountry nature.

There are numerous stream-proximal trail segments where trail users have developed access to the river/reservoir. As these "slides" down the banks are more heavily utilized, the roots that act as steps degrade, visitors create a new access close by, and further destabilize the stream banks for access. Especially in high use areas, such as the rapid/pool structures upstream from Hemlock Overlook, it would be prudent to provide semi-permanent access down the stream banks at the obvious upstream and downstream points of entry.

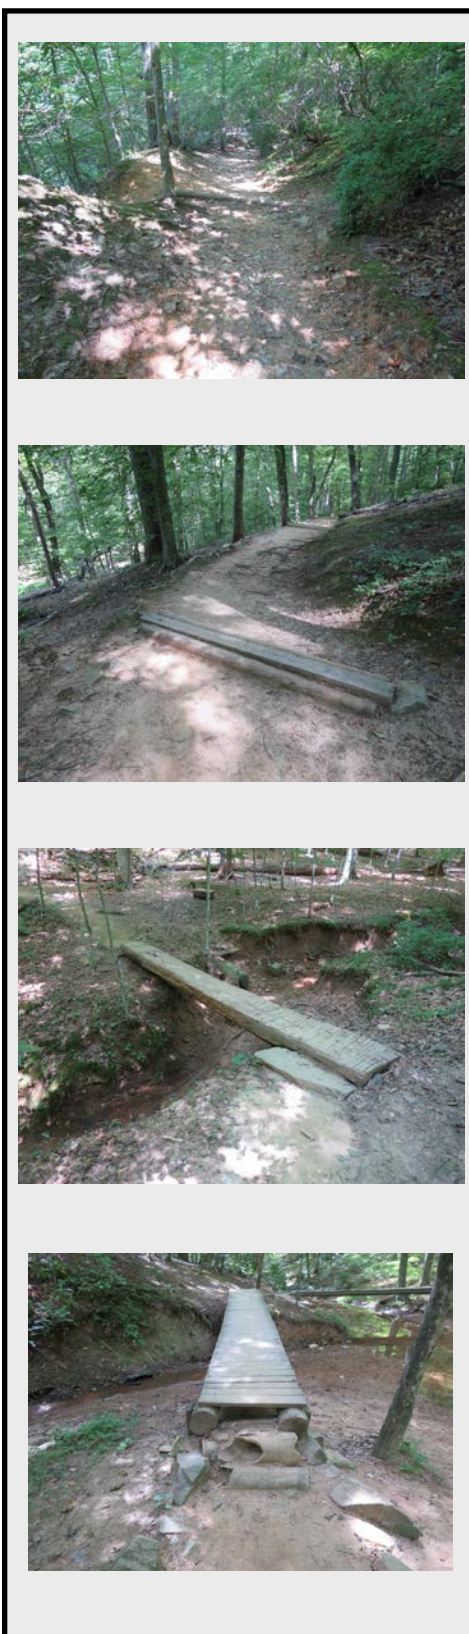
Maintenance of the BROT is highly dependent on a sizable and skilled volunteer trail stewardship contingent. More effective management of water off of the trail is the highest level need currently. As previously stated, this is not possible on most old road segments that have reached a subgrade condition (see top photo, water bar acting as check dam to catch water without redirecting it off trail), nor is it possible on fall line-oriented trails.

Some past attempts have been made to install water bars to better manage water off the trail. In most instances, these structures were poorly sited and/or constructed. When these structures proved ineffective (2nd photo from top, bar directing water into rather than away from the trail), they have regularly been buttressed with additional materials that further exacerbate the drainage management problem and increase user avoidance of the structure. Removing these structures is necessary to minimize trail widening. Retrofitting drainage with natural rolling grade dips is necessary throughout the BROT, though siting and implementation of these structures must be improved for proper water management.

Bridges over side streams are abundant throughout the BROT. Upstream development has resulted in stormwater discharges from these streams that regularly scour and overtop banks. Many of the existing bridges are small, built on floodplains at bankfull elevations where they risk being carried away in a moderate flood (middle bottom photo), and reaching the end of their lifespan with foundations degrading, stringers rotting, and deckboards breaking. Additionally, with stormwater-related degradation, some repairs have been completed in a haphazard manner with insufficient materials such as discarded concrete culverts (bottom photo). With many of the suggested trail relocations occurring in proximity to these bridged crossings, the bridge location has been moved to a higher position on the landscape where flood and rotting effects will be mitigated, but bridge spans and coincidentally costs and construction efforts will increase. When these bridges are replaced, they footers should be located well outside the current channel, structures should have sufficient width to allow for bidirectional passage, and railings should be constructed when bridge decking is three feet or higher above the channel bottom.

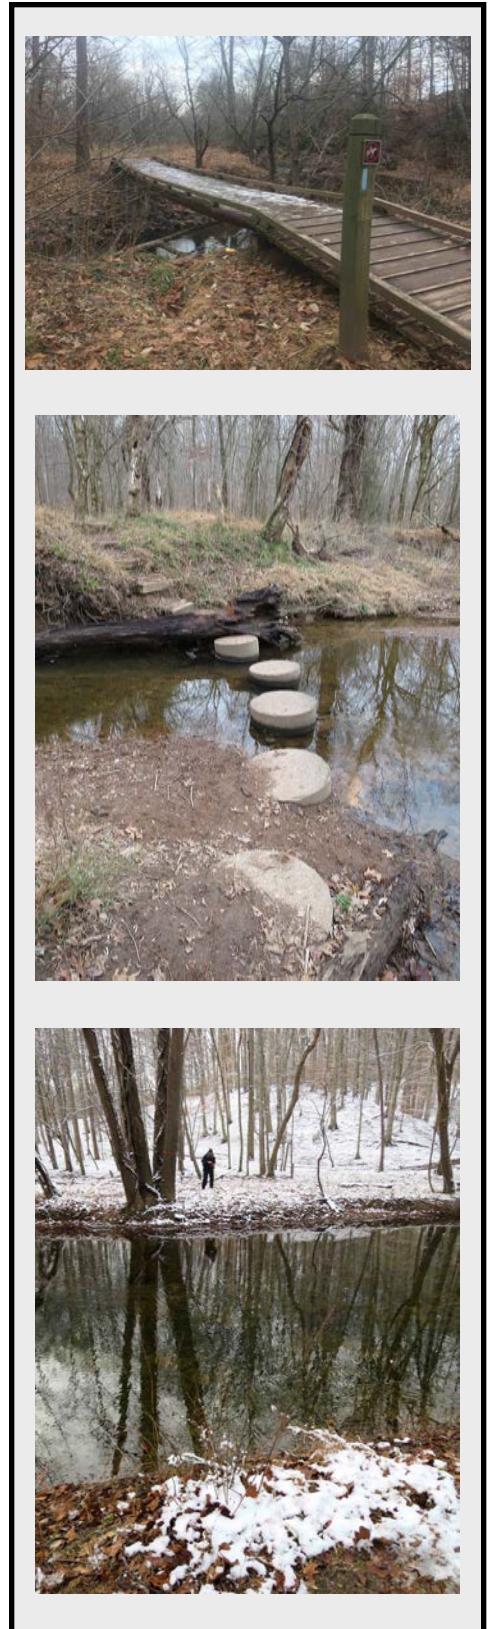
There are a number of notable perennial stream crossings, where large and/or unstable structures currently exist and are problematic. The telephone pole-based bridge structures crossing of Cub Run (top photo) and the crossing near Ordway Road have considerable deflection. The assessment team was able to create 6 inches or greater vertical “bounce” with a single individual on the middle of each bridge. These bridges are quite long and wide and can reasonably allow passage of many individuals at a time, potentially magnifying the deflection. This deflection, along with a lack of railings above relatively high elevations above the typical water level, results in an unnecessarily hazardous situation and should be replaced with engineered structures as soon as is practicable. Designated equestrian fords should be signed and maintained in close proximity to the replaced bridges.

Similarly, the Johnny Moore Creek (middle photo) and Popes Head Creek bollard crossings are problematic. While these structures are solid, stationary, and level when installed, they are not affixed to footers and move under regular stormwater flow events. This renders the bollards unstable and angled at different and sometimes significant angles, increasing the hazardous nature of these crossings. In both locations, removal of the bollards and replacement with bridges spanning the active floodplains are recommended.

Finally, the existing crossing of Wolf Run Shoals has been problematic, washing away in multiple stormwater flow events. The backcountry-style bridge footing will not ever withstand the types of flow that is present in this watershed and a new bridge location will have to span the existing floodway. No adequate, narrow location was found upstream of the current crossing during the field assessment, as the floodplain remained wide to the private property boundary. To address this problematic watershed condition, a bridge location has been recommended at a downstream location (bottom photo) above the pool elevation of the reservoir. While this will require a long span, the location will minimize the scouring effects that have hindered the existing bridge.

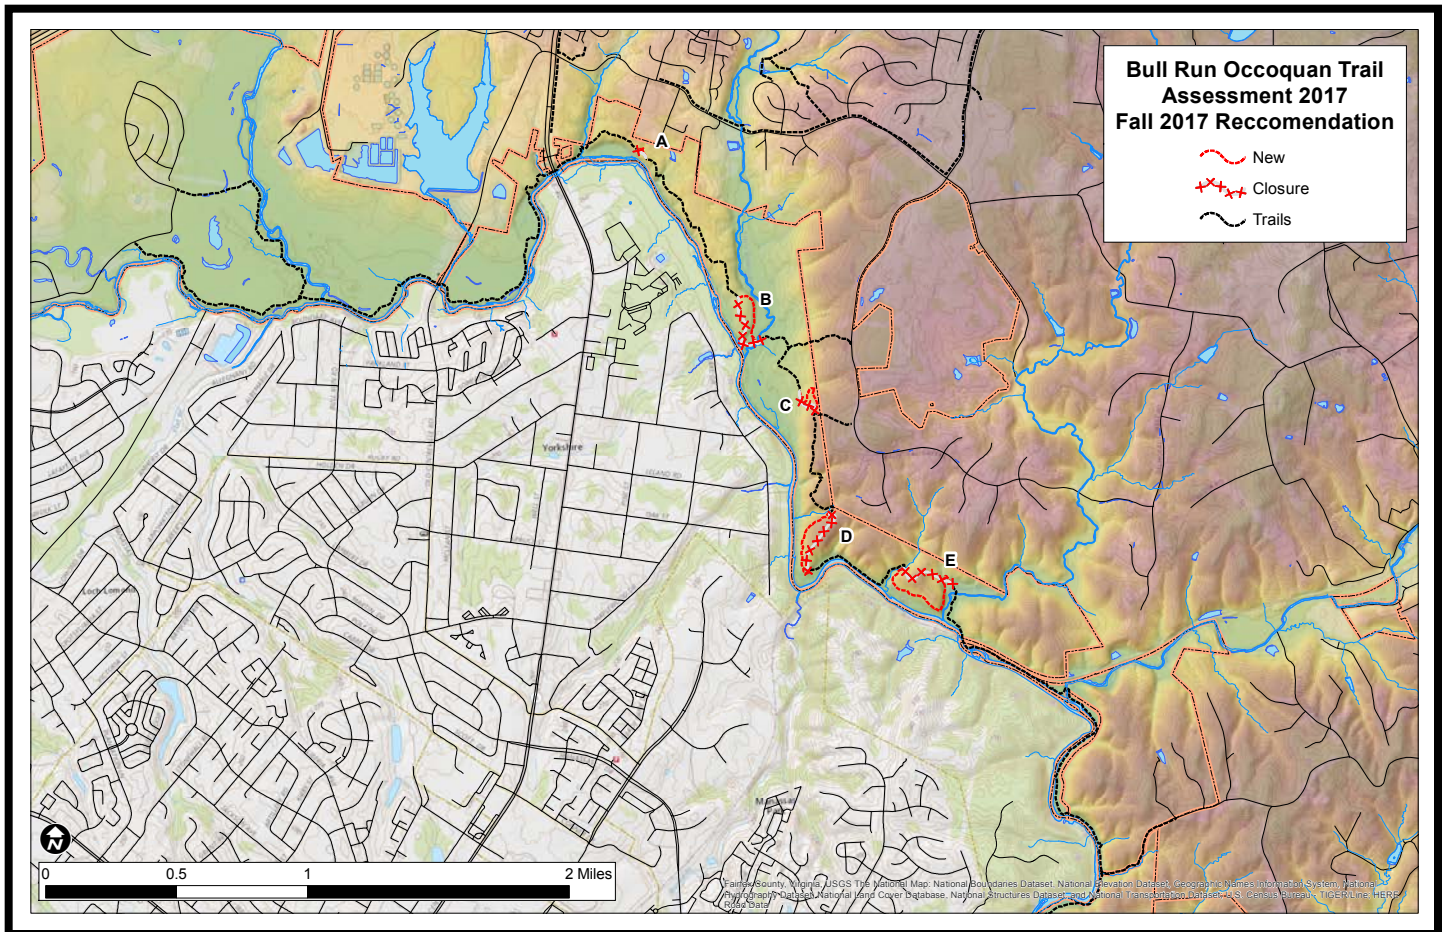
WESTERN HALF- PRIORITIZED ACTIONS

1. (2018, PATC) Improved water management in the form of rolling grade dips should be considered the highest immediate priority, as this maintenance of the existing singletrack trail will assure minimal future changes to the overall good condition of the tread. 40+ rolling grade dip locations have been waypointed in this area.

2. (2018-2019, PATC/NOVA Parks) Improved puncheon structures in Bull Run Park to replace the teak and corduroy mats, placing trail users above the muddy conditions. Additional puncheon and/or turnpike work could be completed in seasonally wet/muddy locations between Cub Run and the Rt. 28 Trailhead to raise the trail tread above the surrounding floodplain.

6. (2022, PATC) Trail relocation/closure projects B and E (3,911 linear feet of singletrack trail construction and 2,804 linear feet of trail closure/reclamation). This also includes the construction larger bridge projects to replace the concrete bollard crossings present on Little Rocky Run (60') and Johnny Moore Creek (48').

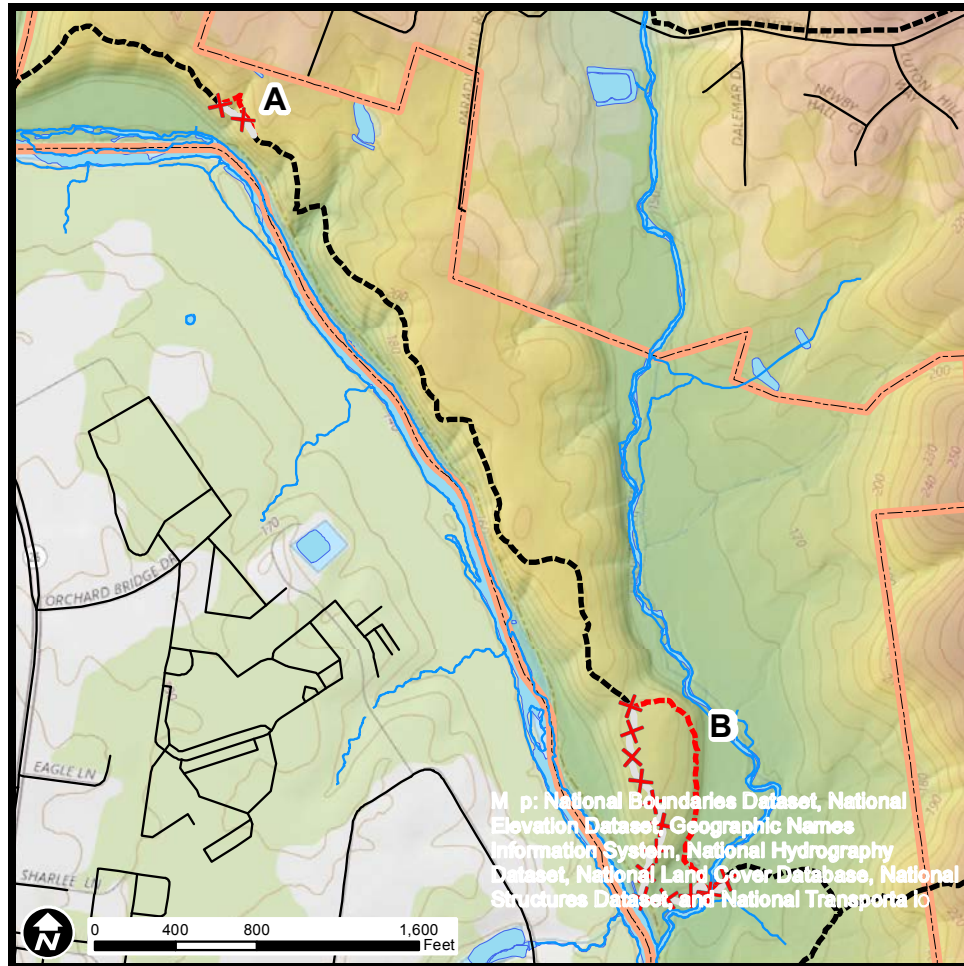
SEGMENT A AND B

Segment: A

New Trail: 339 linear feet/0.06 miles

Structures: 60' bridge or redevelop pillars, 8 steps install or repair, 2 puncheons, 104' total

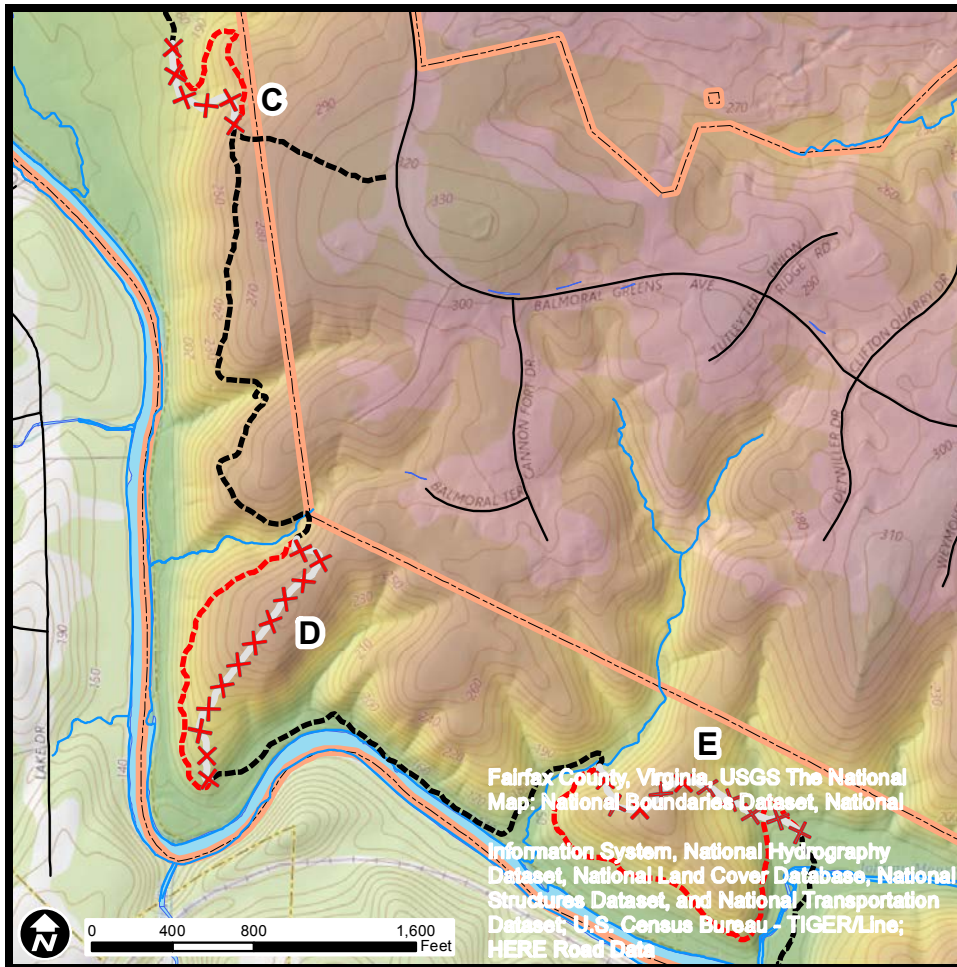
SEGMENT C, D AND E

**Segment: C****New Trail:** 1,177 linear feet/0.22 miles**Trail Closure:** 688 linear feet/0.13 miles**Structures:** 1 switchback turn**Description:** Medium Priority. The relocation removes an eroding, fall-aligned segment of this otherwise very sustainable trail segment.**Segment: D****New Trail:** 1,624 linear feet/0.31 miles**Trail Closure:** 1,533 linear feet/0.29 miles**Structures:** None**Description:** Low Priority. Water management on the existing trail is not feasible due to a subgrade condition that can be replaced with a contour-aligned corridor with dramatic river valley views.**Segment: E****New Trail:** 2,522 linear feet/0.48 miles**Trail Closure:** 1,272 linear feet/0.24 miles**Structures:** 32' bridge**Description:** Medium Priority. Very eroded, fall-aligned trail segment with no possibility of drainage to be replaced with a contour-aligned corridor on steeper, rocky slopes with dramatic river valley views.

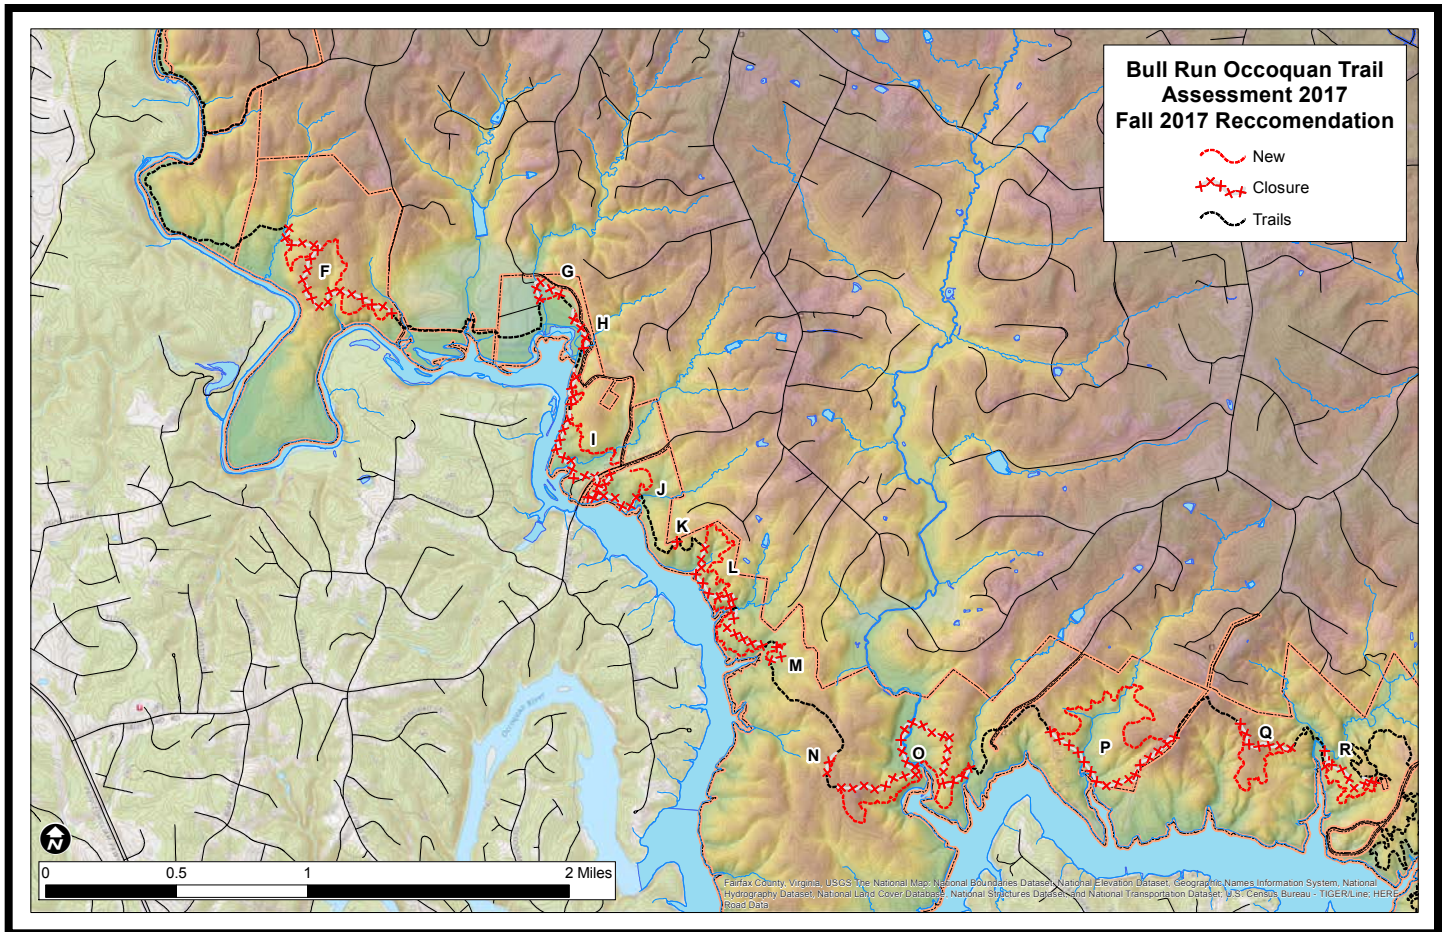
EASTERN HALF

1. (2018, NOVA Parks, PATC, MORE) Relocation/Closure projects I, J, G, and H (4,526 linear feet of singletrack trail construction and 1,350 linear feet of shared-use trail construction, 8,643 linear feet of trail closure, 650 feet of puncheon and a 36' bridge) and the reorientation of the BROT Trailhead that brings users to the eastern portion of the parking area to access the trail and/or cross Old Yates Ford Road at a location with longer sight lines.

2. (2018, PATC/MORE) Improved water management in the form of rolling grade dips should be considered the highest immediate priority, as this maintenance of the existing singletrack trail will assure minimal future changes to the overall good condition of the tread where future relocations have not been recommended. 50+ rolling grade dip locations have been waypointed in this area.

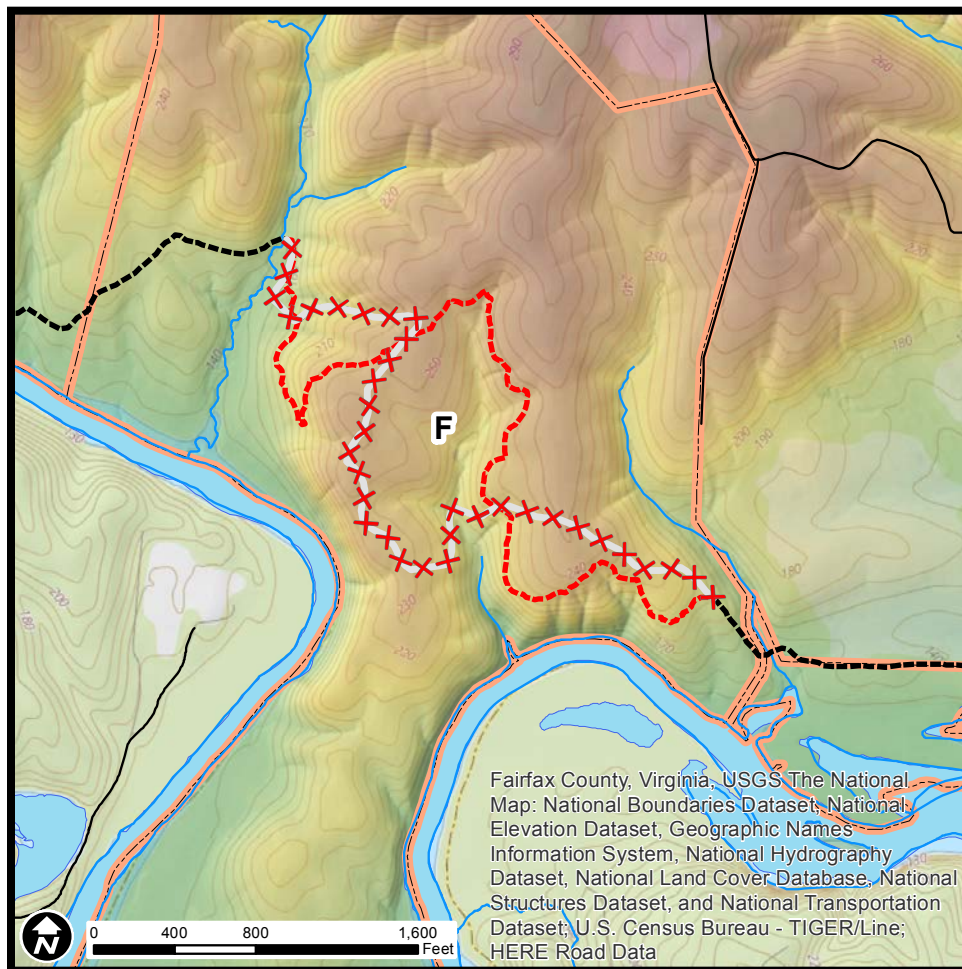
SEGMENT F

**Segment:** F**New Trail:** 5,459 linear feet/1.03 miles**Trail Closure:** 4,529 linear feet/0.86 miles**Structures:** 1 switchback turn

Description: Low Priority. The relocation addresses a number of fall-aligned trail segments that are carrying sediment to the stream crossing locations. Removing the crossing of the eastern stream and a contour-aligned approach to the western stream will mitigate this issue. The relocated segments at the brow of steep slopes down to the river provide enhanced views of the Bull Run valley.

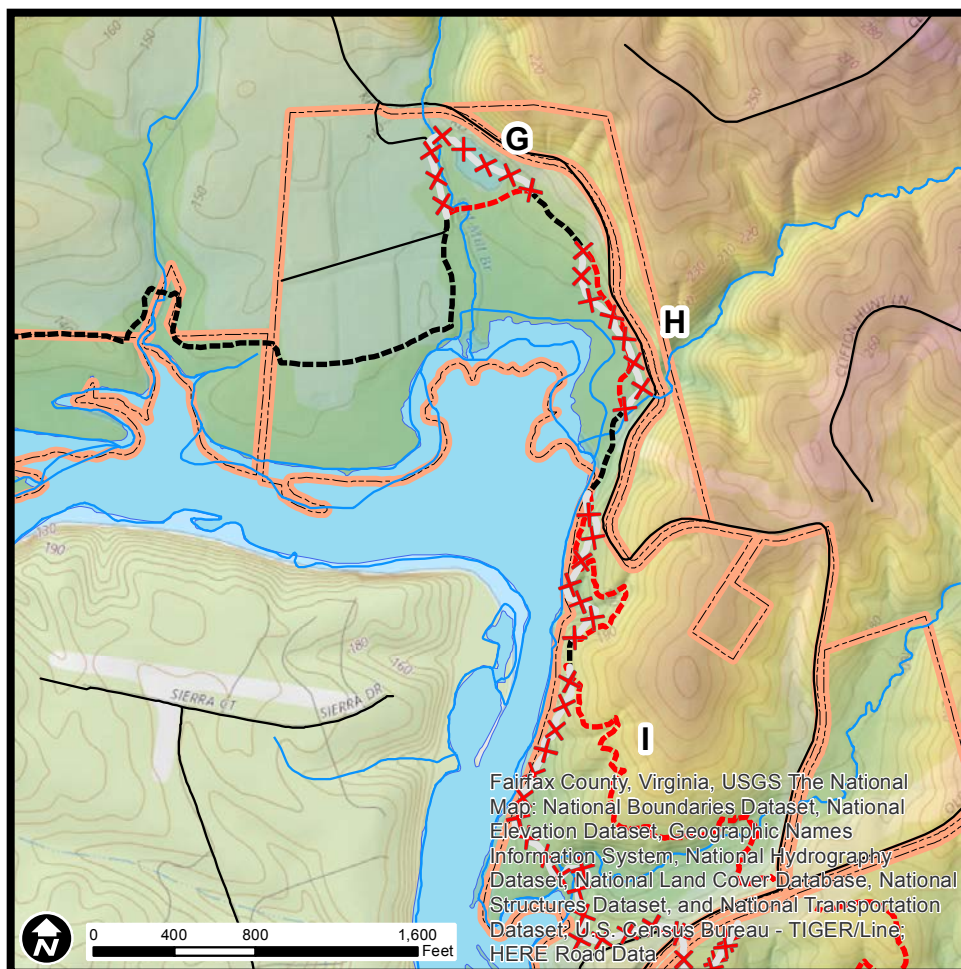
SEGMENT G, H, AND I

**Segment: G****New Trail:** 433 linear feet/0.08 miles**Trail Closure:** 989 linear feet/0.19 miles**Structures:** 400' puncheon**Description:** Medium Priority. The relocation moves the trail off the main portion of the gravel road entrance to the ball fields and follows a marginally drier ditch that, with puncheon, will provide a drier trail experience.**Segment: H****New Trail:** 874 linear feet/0.17 miles**Trail Closure:** 922 linear feet/0.17 miles**Structures:** None**Description:** High Priority. The relocation moves the trail approximately 25' laterally, out of the floodplain, where trail muddiness, braiding and maintenance will not be as challenging.**Segment: I****New Trail:** 3,219 linear feet/0.61 miles**Trail Closure:** 3,915 linear feet/0.74 miles**Structures:** 32' bridge, 6 puncheons totalling 250', 36' bridge, Yates Ford Road crossing fix**Description:** Medium Priority. The relocation addresses a number of fall line issues and increases safety with a road crossing with improved sightlines.

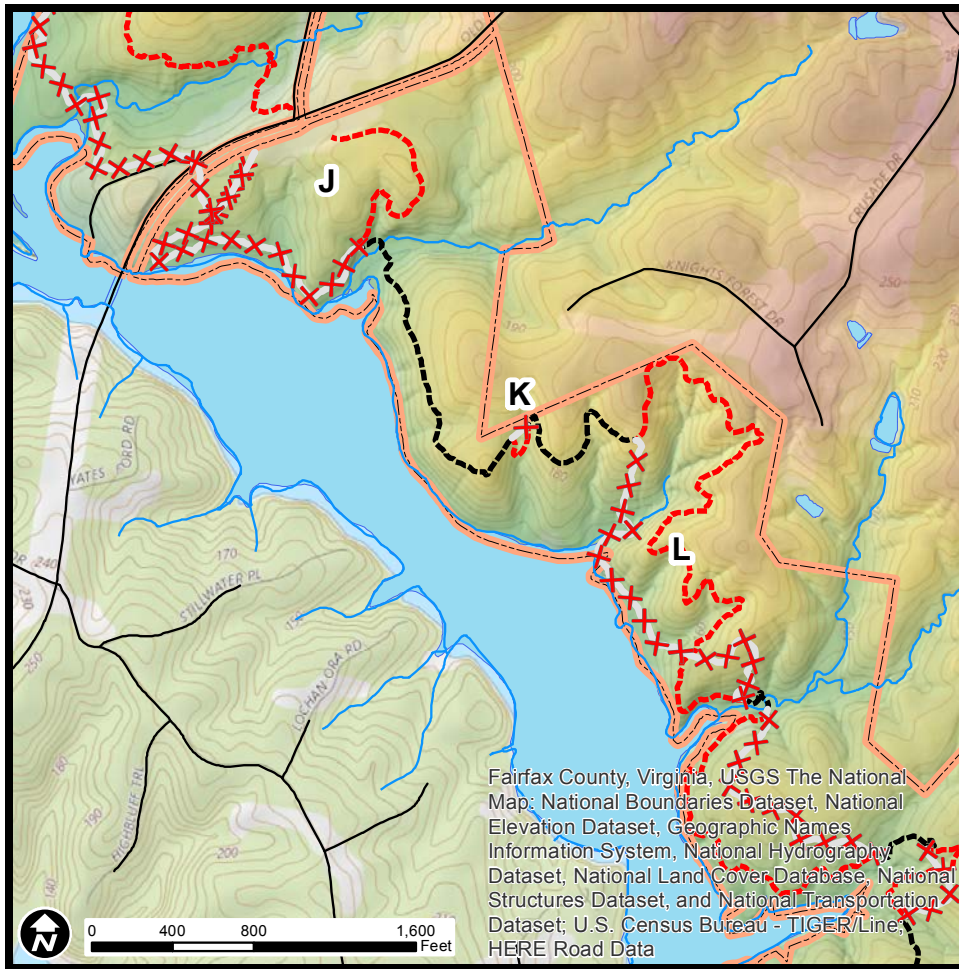
SEGMENT J, K, AND L

**Segment: J****New Trail:** 1,350 linear feet/0.26 miles**Trail Closure:** 2,817 linear feet/0.53 miles**Structures:** 1 switchback turn**Description:** High Priority. The relocation reduces the deferred maintenance of the fall-aligned fishing access trails and requires reorienting the trailhead to the opposite end of the existing parking area.**Segment: K****New Trail:** 272 linear feet/0.05 miles**Trail Closure:** 97 linear feet/0.02 miles**Structures:** 2 rolling grade dips**Description:** High Priority. The relocation is short and replaces a rapidly degrading fall-aligned segment.**Segment: L****New Trail:** 3,662 linear feet/0.69 miles**Trail Closure:** 2,232 linear feet/0.42 miles**Structures:** 24' and 36' bridges, 4 rolling grade dips, 8 puncheons totalling 180'**Description:** Medium Priority. The relocation replaces numerous fall-aligned segments and eroding, retaining-walled trail with more sustainable, bridged crossing locations higher in the watershed with portions near private property located on existing equine trail..

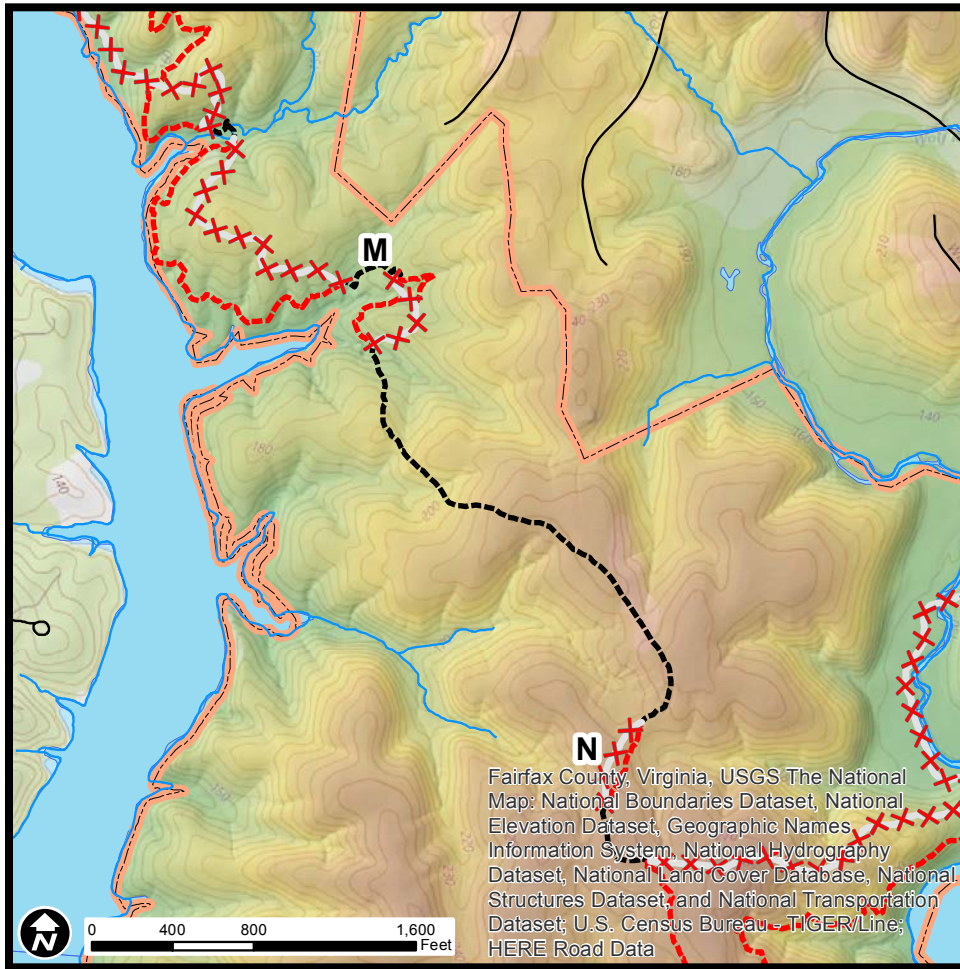
SEGMENT M

**Segment: M****New Trail:** 3,101 linear feet/0.59 miles**Trail Closure:** 1,923 linear feet/0.36 miles**Structures:** 36' bridge

Description: Medium Priority. The existing trail is fall-aligned as it enters the two stream valleys and the required maintenance to retain this alignment will be significant and recurring. The relocation provides for a contour-aligned route and enhanced views of the lake. An improved bridge crossing will span the channel and immediate floodplain, which demonstrates signs of considerable seasonal muddiness.

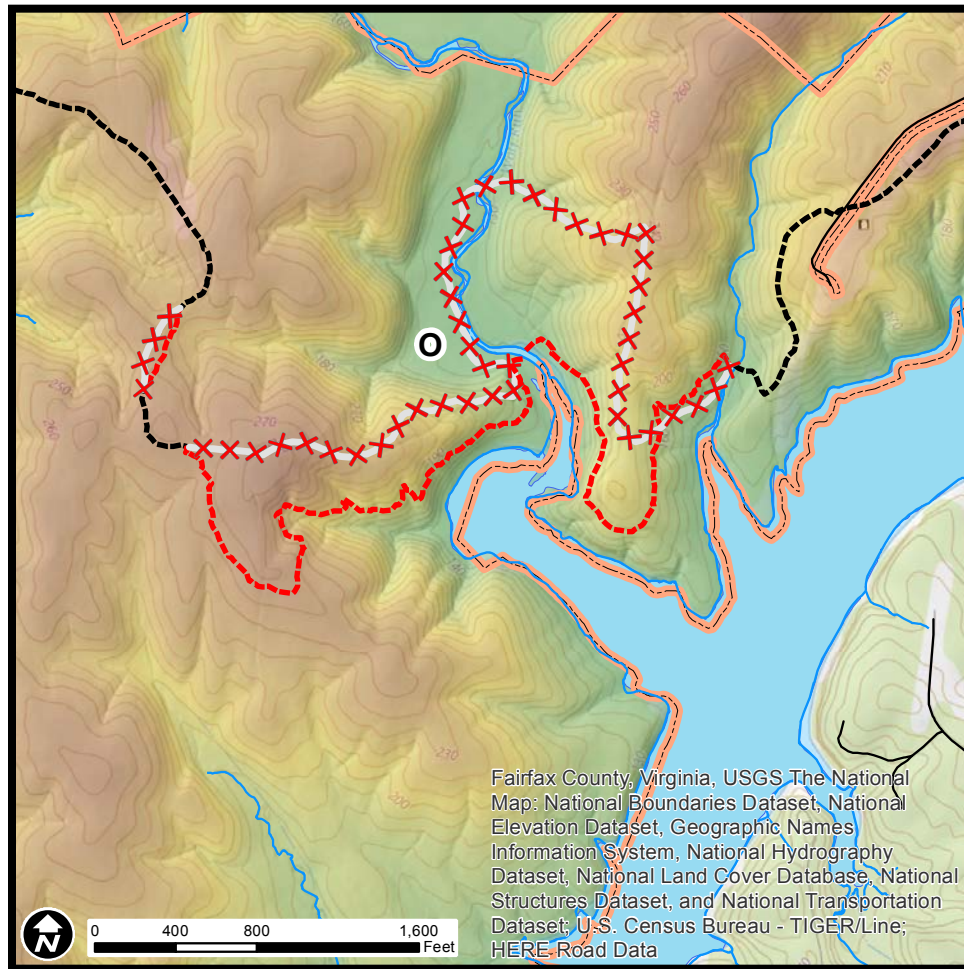
SEGMENT O

**Segment: O****New Trail:** 6,185 linear feet/1.17 miles**Trail Closure:** 5,728 linear feet/1.08 miles**Structures:** 44' and 70' bridges, 3 puncheons totalling 68', 400' road to trail conversion**Description:** High Priority. The bridge over Wolf Mill Shoals has been damaged/removed by flood waters on multiple occasions, the floodplain location of the existing trail is braiding and widening as trail users search for the driest conditions, and the fall-aligned segments of trail down to the valley are not maintainable and pose use conflict risks.

Alternative crossing locations upstream of the existing bridge were evaluated, but the wide, wet, active floodplain persists north to the private property boundary. A crossing location has been proposed that is within the pool of the lake. This mitigates long-term flood damage potential, but requires a longer span. Contour-aligned trail relocations will provide for sustainable trail development with longer sight lines and enhanced lake views on both aspects of this scenic cove, while minimizing the length of trail located on the persistently

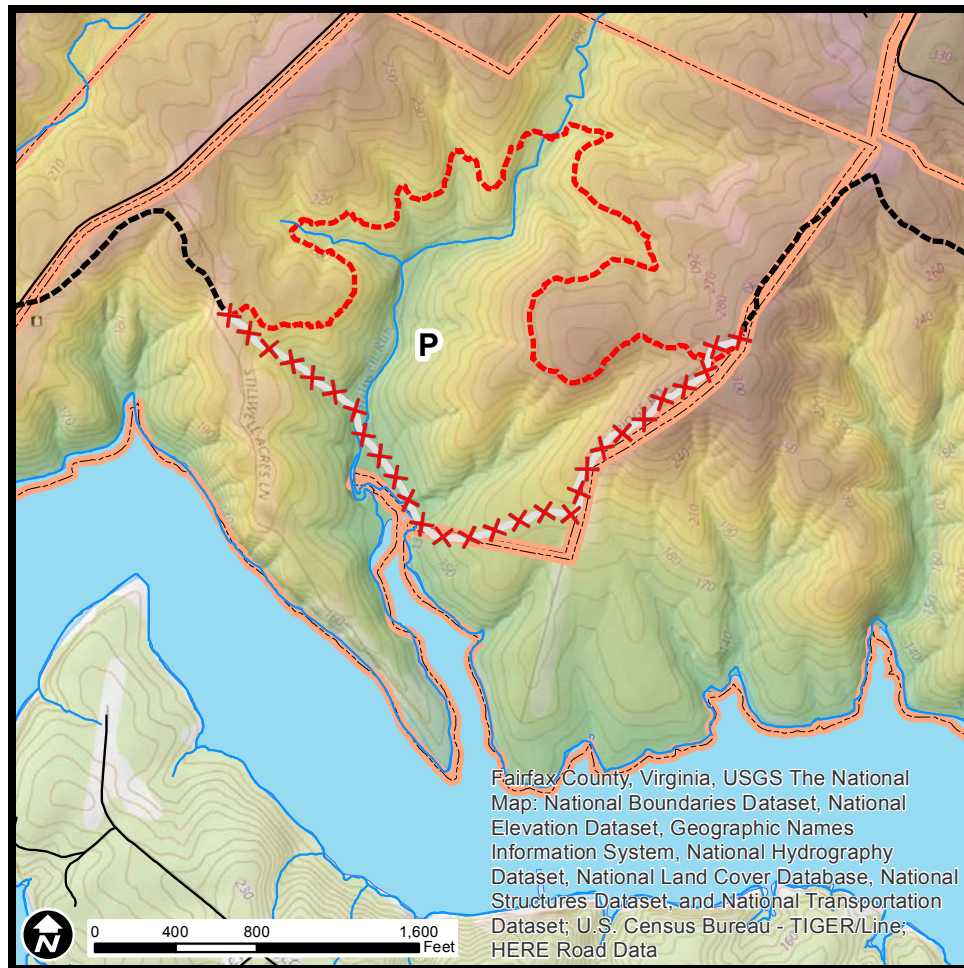
SEGMENT P

Segment: P

New Trail: 7,139 linear feet/1.35 miles

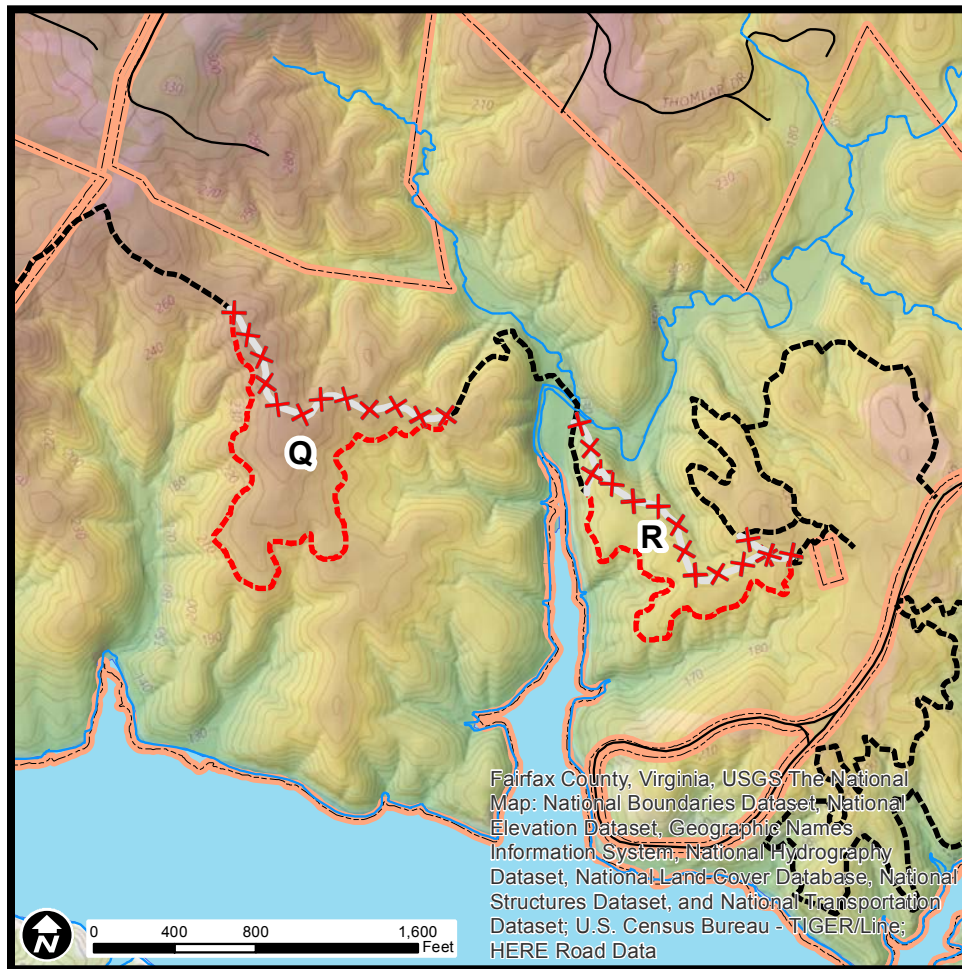
SEGMENT Q AND R

Segment: Q

New Trail: 3,686 linear feet/0.70 miles

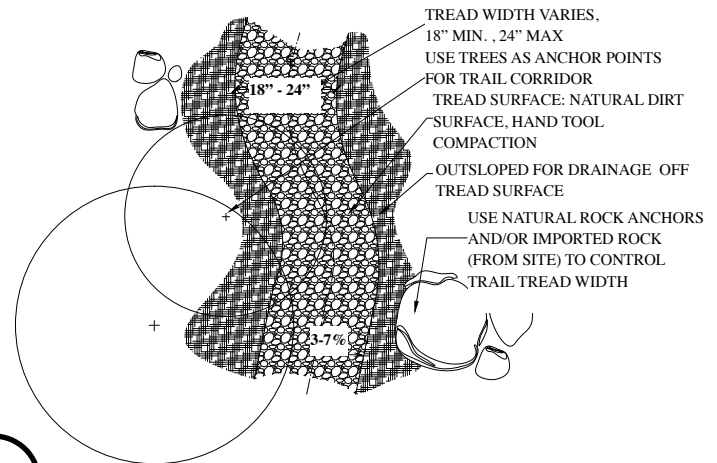
1.1

Average Gradient: <10%
Maximum Sustained Grade: 15%
Maximum Grade: 25% for short distances
Typical Tread Materials: Natural surface, may be amended with aggregate, if necessary, in seasonal wet areas
Sideslope Steepness: Flat to 70%

Turn Radius: 4' minimum
Trail/Structure Formality: Durable but rustic, 36" minimum width
Wet Area Crossing Formality: Durable but rustic bridges/puncheons for minor/major crossings
Duty of Care: Moderate

PLAN DETAIL: SINGLETRACK TYP.

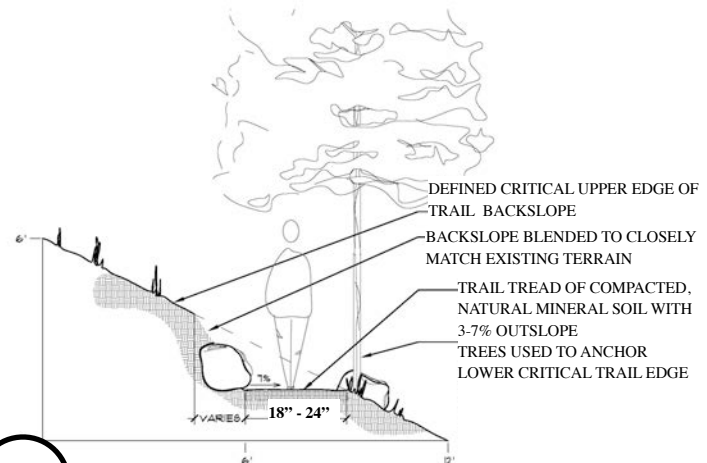
1.2

SECTION DETAIL: SINGLETRACK TYP.

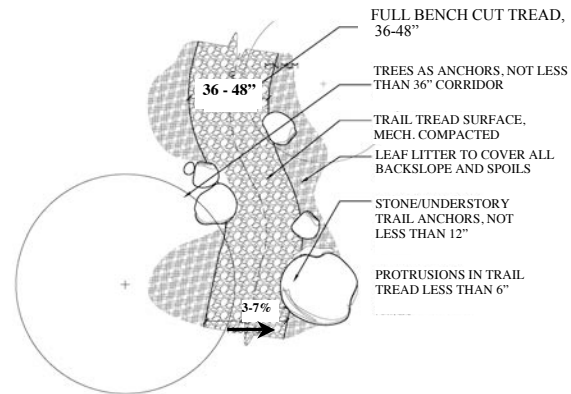
3.1

Typical Tread Materials: Mostly natural surface (native soils) with some rock. Some loose material possible

Wet Area Crossing Formality: Bridges/puncheons to extend beyond current banks, constructed on rock/concrete abutments, and smooth entry/exit ramps

PLAN DETAIL: BACKCOUNTRY TRAIL TYP.

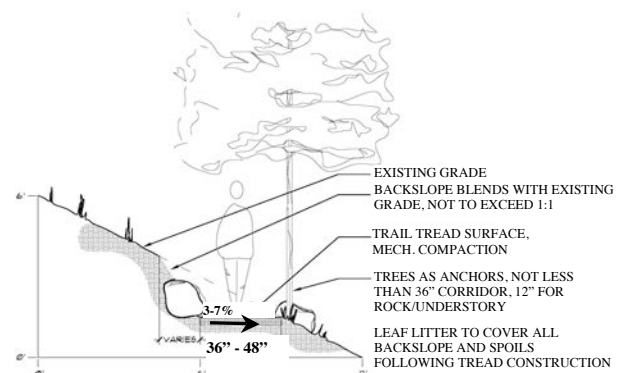
3.2

SECTION DETAIL: BACKCOUNTRY TRAIL- TYP.

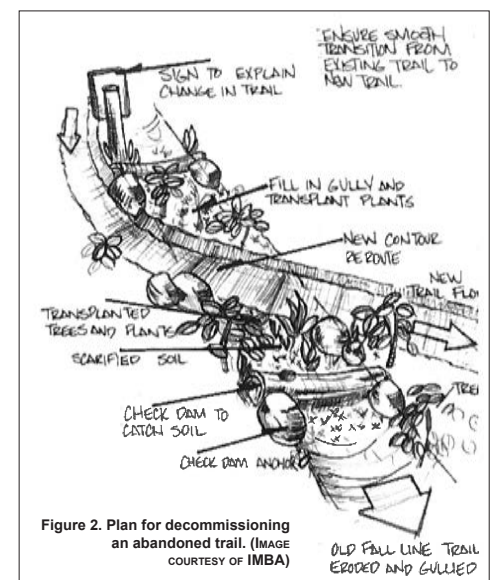
When use of the closed route is stopped, restoration of natural hydrologic and vegetation patterns can be effectively initiated. If an erosion gully is present, filling that depression is necessary to

restore natural hydrologic patterns. Check dams of the depth of the gully should be constructed at intervals to catch and retain sediment being transported downslope. These dams can be constructed with woody materials (large rounds from dead trees or smaller materials bound together with twine or bailing wire) or rock (large rocks or rip rap) where available.

If sufficient rock and/or woody debris is not available, coconut coir logs are effective erosion control products that allow water to flow through the check dam, but catch and hold rock, sediment, and seed materials upslope of the dam. These are made from natural fibers and decompose over time. The coir logs can also be used to reestablish vegetation by “plugging” live root specimens into the log. In more extreme cases of erosion and slope stabilization, use jute mat can be laid under the coir logs. This treatment adds additional organic matter to aid in vegetative regeneration and can also be used as a planting substrate for seed or live root seedlings.

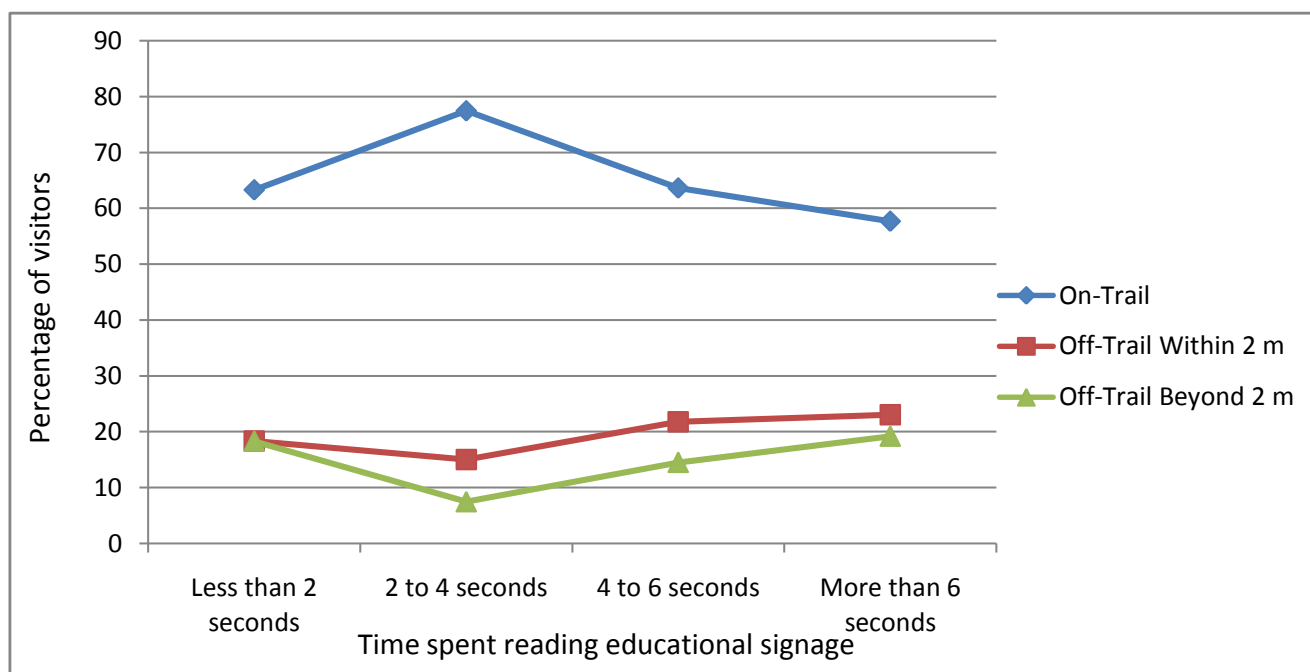
Signage Reading Time	On-Trail Percentage (n)	Percentage Off-Trail Within 2 m (n)	Percentage Off-Trail Beyond 2 m (n)	Total
Less than 2 seconds	63.30 (176)	18.34 (51)	18.34 (51)	278
2 to 4 seconds	77.44 (103)	15.03 (20)	7.518 (10)	133
4 to 6 seconds	63.63 (35)	21.81 (12)	14.54 (8)	55
More than 6 seconds	57.69 (30)	23.07 (12)	19.23 (10)	52
Total	66.40 (344)	18.33 (95)	15.25 (79)	518

Figure 4-2. Time spent reading educational signage and the effect on off-trail behavior rates.
