# Bank of Alexandria

## Façade Assessment

1200AE PROJECT NO. 19-029

July 29, 2019

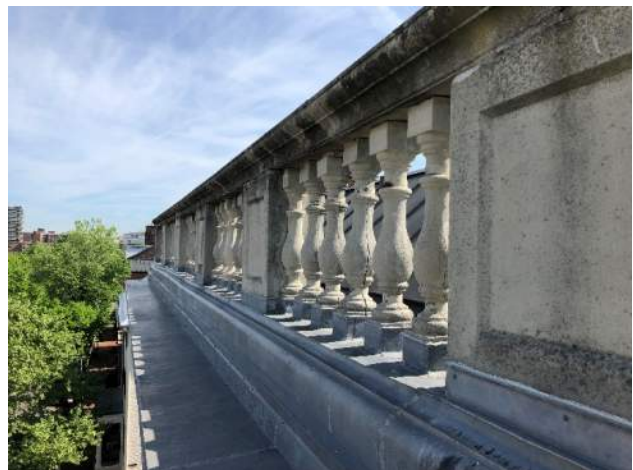
Figure 7: Cast concrete balustrade on west elevation.

As noted above, the cast concrete balustrade characterizes the upper portion of the north and west elevations, with balusters extending between a cast concrete base and a cast concrete railing (Figure 7). The balustrade extends beyond the roof to create a parapet detail on these elevations. Runs of balusters are separated by large cast concrete piers with brick masonry back up. Railing elements are cramped into place at joints and at piers locations (Figure 11). Balusters are a pair of matched cast concrete pieces each with an embedded metal rod joined at their halves with a thin mortar seam. In addition to the rod embedment, the individual balusters appear to be connected through grout pads at each end (Figure 12), although the base connection is not able to be observed due to the existing flashing details. The balustrade assembly bears directly on the stone cornice detailing and brick masonry wall construction below. This balustrade is a replacement element from the 1970s era restoration.

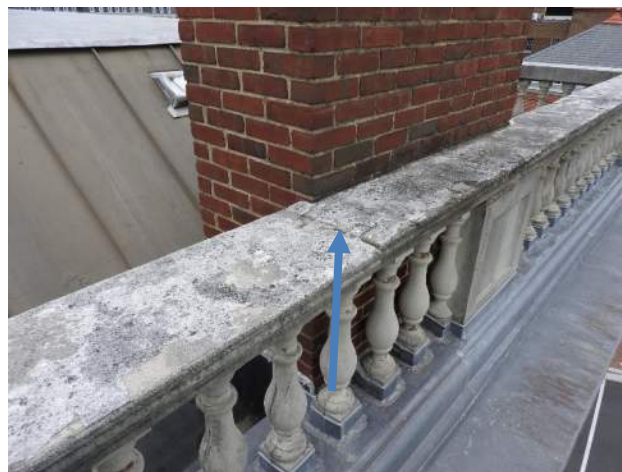
Currently, the concrete rail has large areas of staining and biological growth. At the southern end of the west façade balustrade, two railing stones have shifted inward, away from the wall face, with 1-1/4" movement noted at the southern end (Figure 13). Based on observations, the cramp detail has failed, likely due to corrosion (Figure 14). In this area, visible separation exists between individual balusters and rail elements.

Figure 11: Top side of balustrade assembly, with cramps visible.

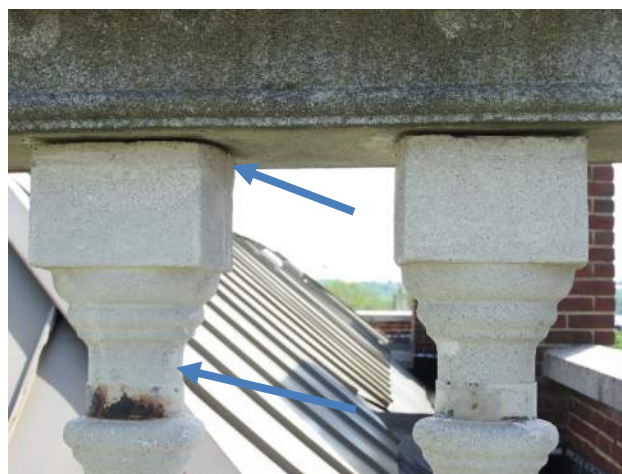
Figure 12: Top of baluster grout pad connection to concrete railing, with crimps at balusters.

Several of the balusters are loose and can be easily moved by hand (Figure 15). The paired elements forming the individual balusters are generally held in place via a metal crimp attached to the upper and lower portions of the baluster (Figure 12, above), which was likely added as part of the original installation of this concrete assembly, once deterioration caused separation between baluster faces. These crimps generally exhibit superficial corrosion, and some are loose. More than thirty of the balusters show signs of cracking and separation of the paired elements. Most of the observed cracking in the balusters would be considered significant – with more than half those observed exhibiting deep cracking and separation or spalled concrete (Figure 16 and Figure 17). Generally, where able to be observed, the existing interior metal rods are corroded with significant section loss.

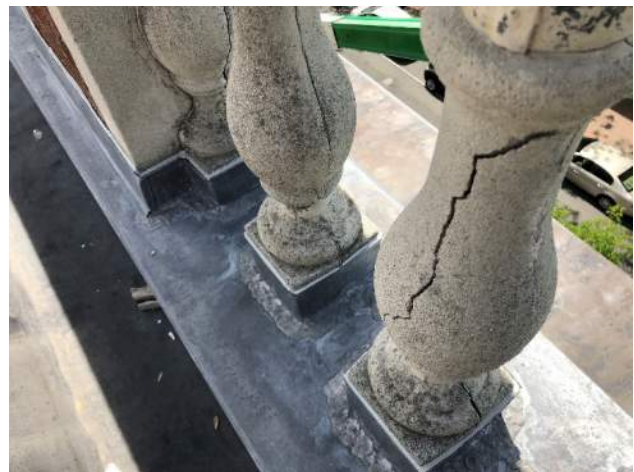
Generally, the concrete piers appear to be in good condition. Due to the existing flashing detail, conditions at the base of the balustrade assembly were unable to be reviewed (Figure 18). Specific conditions of the balustrade assembly observed on site are documented on S301 in the attached Appendix A.

Figure 18: Flashing detail at base of balustrade assembly and at base of individual balusters.

The balusters and associated connecting elements should be individually repaired or replaced, as required based on the existing condition. Replacement balusters should be detailed with a mechanical attachment to the base of the balustrade assembly. It should be assumed that baluster elements require replacement, in order to remove existing deteriorated and corroded portions of the existing balustrade assembly. This will require removal and replacement of the existing flashing details at the balustrade.

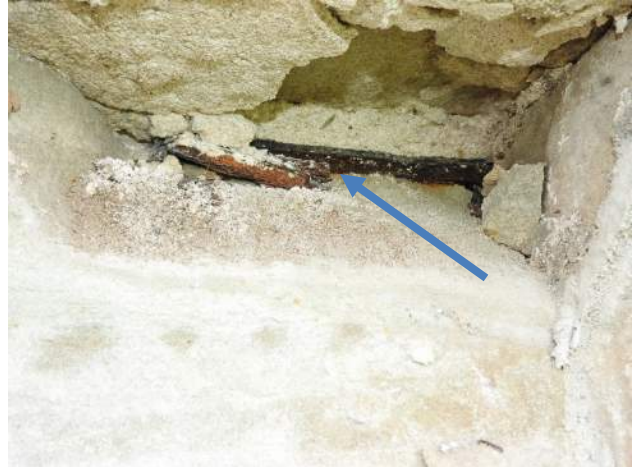
Figure 21: Remnants of iron tie at removed stone.

At the north elevation, discrete areas of the stone cornice and frieze were noted to be loose (Figure 27). In three areas of the north elevation, loose stone was removed from the building in order to limit falling hazards (Figure 21 and Figure 28). These locations are noted in S301 in Appendix A. Where material was removed from the stone detailing, the historic metal anchors were observed to be corroded, with significant cross-sectional loss (Figure 21, above). The remaining stone in areas of removal had damp feeling surfaces, indicating that water infiltrates the stone detailing, either through gaps in the existing flashing or by infiltrating through the stone, roof, or wall surfaces. Remnants of stone removed from the structure were given to the Owner.

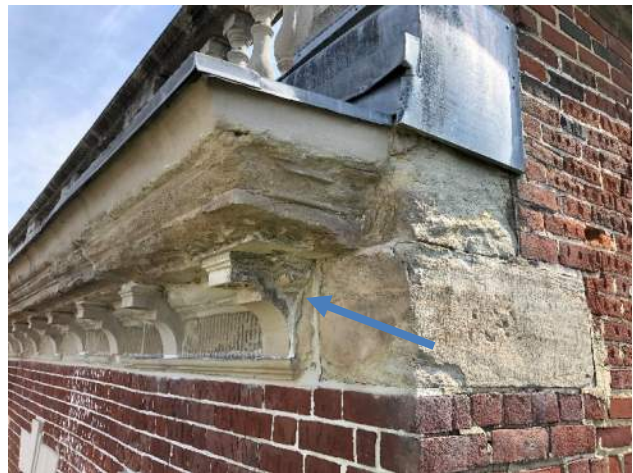
As discussed above, the stone cornice and frieze create the architectural detail below the existing balustrade assembly. The cornice extends beyond the face of the existing masonry wall construction, transitioning to the frieze, which consists of decorative bracket elements and fluted panels. At the base of the frieze detail, the stone bears on the existing brick masonry wall. Based on observations, the cantilevered stone cornice elements obtain stability from the counterweight of the balustrade above (Figure 10, above). An embedded metal strap or cramp was uncovered at two locations. The cramp appears to connect adjacent frieze and embedded bracket stones within the bed joint below the cornice stones (Figure 21). At the ends of the cornice and frieze detail, the frieze stone turns the corner onto the east and south elevations of the main bank block with a quoin detail. There is evidence of past limewash around the bracket elements of the stonework (Figure 22).

Figure 22: Remnants of historic limewash on face of bracket.

Consideration should be given to coating the existing stone with an appropriate breathable coating, such as limewash. Such a coating would have been typical for this stone historically and would help protect the surface of the material. It is important that any coating on this type of stone be breathable to allow for appropriate movement of water through the material. In addition, given the combined ongoing mechanisms of deterioration in both the stone itself and with embedded metal straps, a long-term solution of doing a full reconstruction of the cornice should be considered. The need to deconstruct and repair or rebuild the balustrade and its integral flashing may be another impetus to address the cornice and balustrade as a combined project.

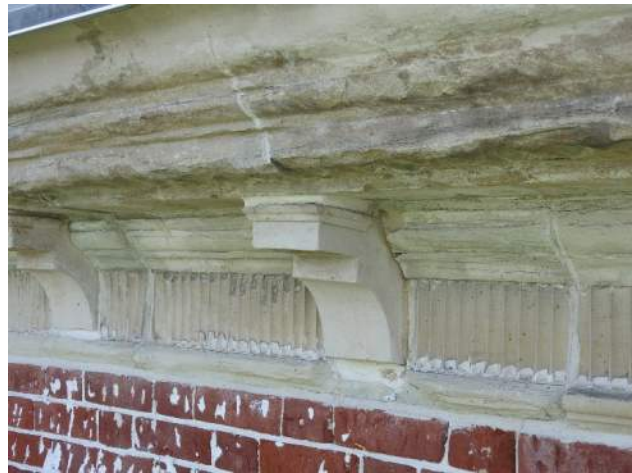
the west cornice detail have signs of previous patching efforts on the stone masonry. At the west elevation, several of the stone brackets were replaced with a replacement stone or cast concrete bracket which were set by cutting out the stonework, placing the concrete bracket, and placing mortar between the joints (Figure 25). It is unknown if any pinning was used to anchor the replacement brackets into the substrate. Areas of the cornice, particularly along the west elevation, have signs of significant cracking in the stone masonry (Figure 26). Some of these cracks appear to have been previously repointed, while others appear to have opened following past repair campaigns. Specific locations of conditions noted on site are documented on S301 of the attached Appendix A.

Figure 25: Replaced bracket detail at west elevation.

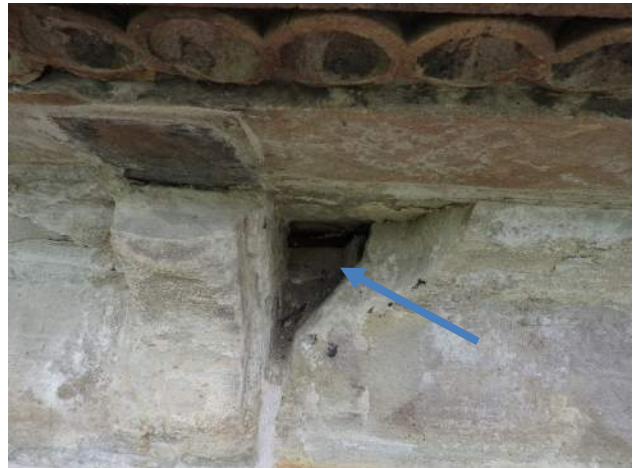
Figure 28: Area of removed stone at north elevation frieze detail.

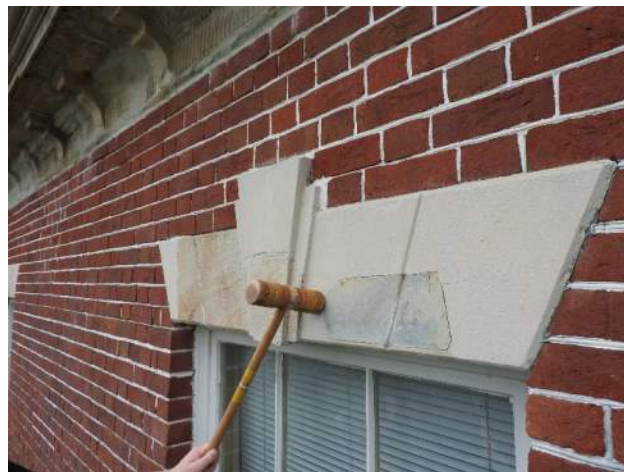
The stone lintels and sills on the west elevation generally appear to be in fair condition, although isolated areas of deterioration were noted, particularly at the existing third floor lintels. More significant signs of deterioration were noted on the north elevation. A majority of the original stone lintels and sills have been previously patched to recreate some amount of surface detailing at the stone lintels (Figure 29). Where stone elements have been replaced with concrete, it is generally cast concrete with an exposed aggregate finish (Figure 30). In some areas, replacement concrete elements were observed to have a parge coat or similar applied surface finish, generally to aid in water runoff. Observed conditions are summarized on S201 and S202 of Appendix A.

Figure 29: Typical stone lintel with patching.

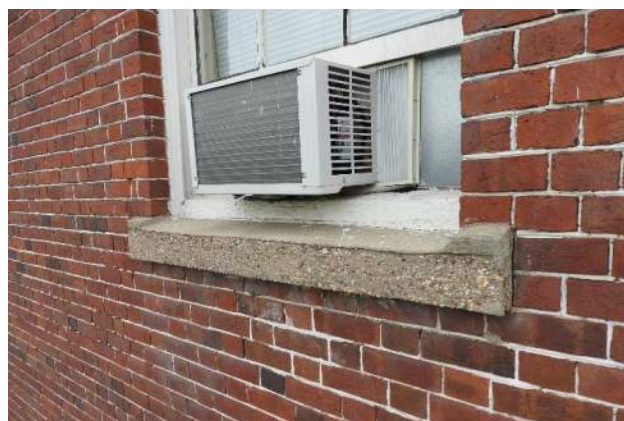
Figure 30: Typical replacement concrete sill with cementitious parging at topside.

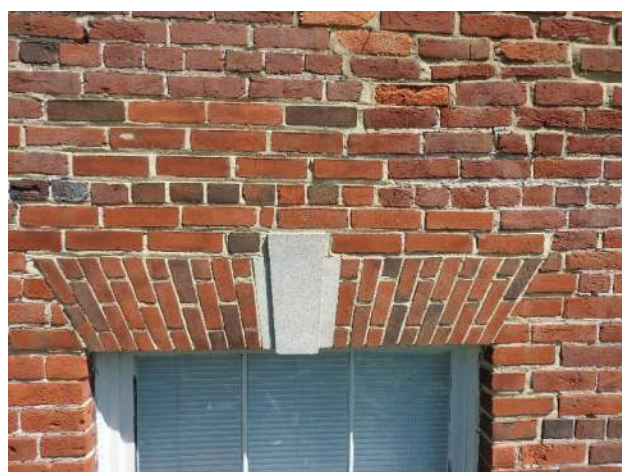
At the east and south elevations, where most openings were created or restored as part of the 1970s era work, existing lintels were observed to be steel with brick and stone elements to create the appearance of a traditional arched brick opening (Figure 36). The lintels were observed to generally appear in good condition, with few signs of surface staining or other deterioration. Observed conditions are summarized on S202 and S203 in Appendix A.

Figure 36: Typical modern lintel configuration at south and east elevations.

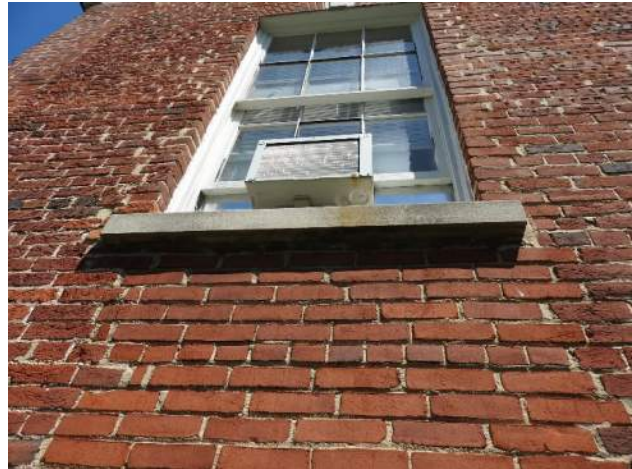
At the east and south elevations, where most openings were created or restored as part of the 1970s era work, existing sills were observed to be cast concrete (Figure 38). The sills were observed to generally appear in good condition, with few signs of surface staining or other deterioration.

Figure 38: Typical modern cast concrete sill on south and east elevations.

No specific conditions which require repair were noted at this time.

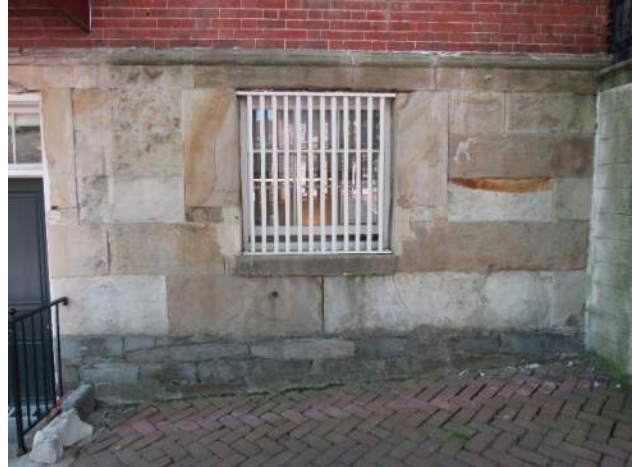
The brick masonry transitions to a stone base at the north and west elevations (Figure 43), as noted above, with areas of stonework also visible on the south and east elevations. At the north and west elevations, the stone consists of an Aquia sandstone band which transitions to bluestone near grade. It appears that some stones may have been replaced with a new stone where particularly deteriorated. These stones are likely a Briar Hill Sandstone, an accepted replacement material, as the historic Aquia sandstone is no longer quarried. At the south and east elevations, only areas of bluestone or granite were observed (Figure 44).

At the north and west elevations, the sandstone shows signs of significant deterioration. Observed conditions are summarized in sheets S100 through S104 and S 201 and 1/S201 in Appendix A. It appears large portions of the stone face have been lost, either through spalls or flaking of the dressed stone face (Figure 45 and Figure 46). There are areas of voids in the stone construction, with some voids greater than 1" deep. Several areas where there has been section loss correspond with the locations of embedded iron ties, lintels, and grates. It appears that with long-term moisture infiltration into the stonework, the iron ties have corroded, causing cracking and spalls in the sandstone (Figure 47). When sounded, many areas of the sandstone appear to be hollow or unsound. Of additional concern, multiple stones were noted to have been originally placed

Figure 43: Typical sandstone band transitioning to bluestone on north elevation.

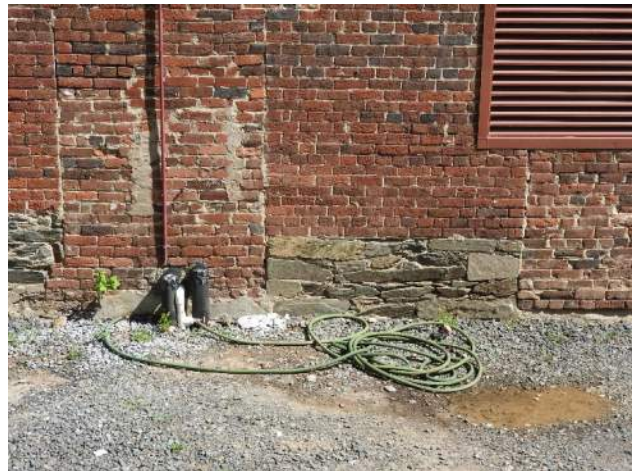
Figure 44: Granite at base of brick on south elevation.

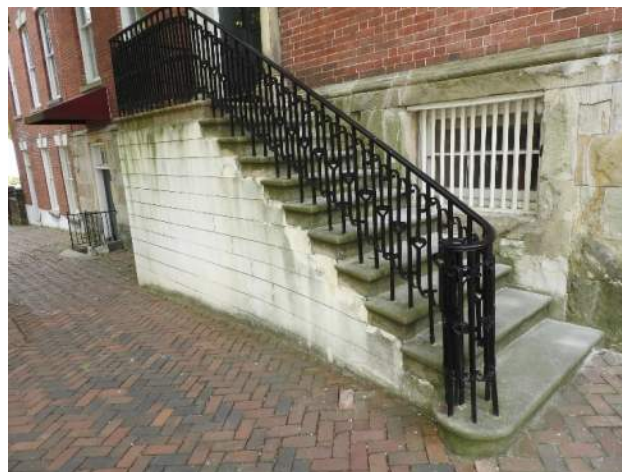
The two main entries on the north and west elevations are accessed via decorative stone staircases (Figure 50) and a decorative stone surround at each doorway (Figure 51). The outside stone face of each of these staircases has been covered with a stucco or similar cementitious coating. Some past patching exists at the entry surrounds. Based on historic photographs, the patching and stair stucco finish was added as part of the 1970s work over the historic stonework.

Figure 50: North stair construction with stucco coating.

Existing masonry should be cleaned and repointed with an appropriate mortar. Existing cracks should be cleaned and pointed.

Loose material and spalls should be removed from the surface of the stone, including surface contaminants such as salts, or stabilized in place. Remaining stone should be dressed to allow water to shed from the surface.

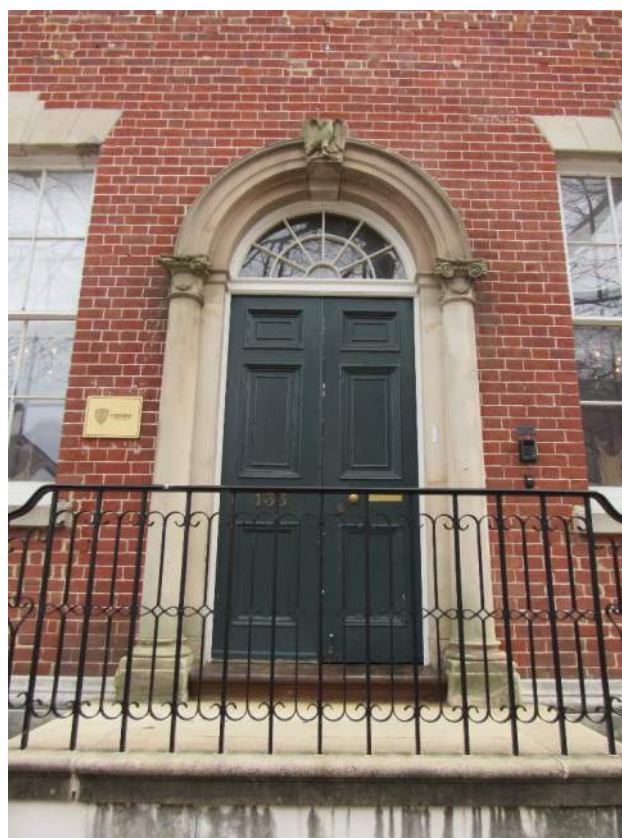
Figure 51: Stone surround at north entry.

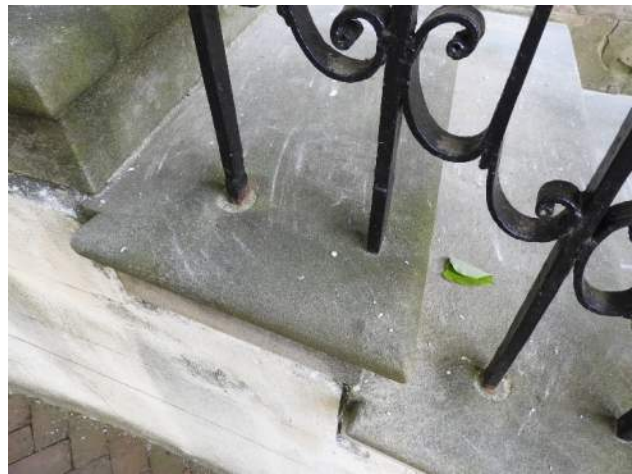
Attached to the two historic exterior stairs are cast iron railing elements embedded into the stonework (Figure 56), providing a guard at the edge of the stair construction. Localized areas of section loss near embedment points in the stone

Figure 56: Typical railing embedment at stone treads.

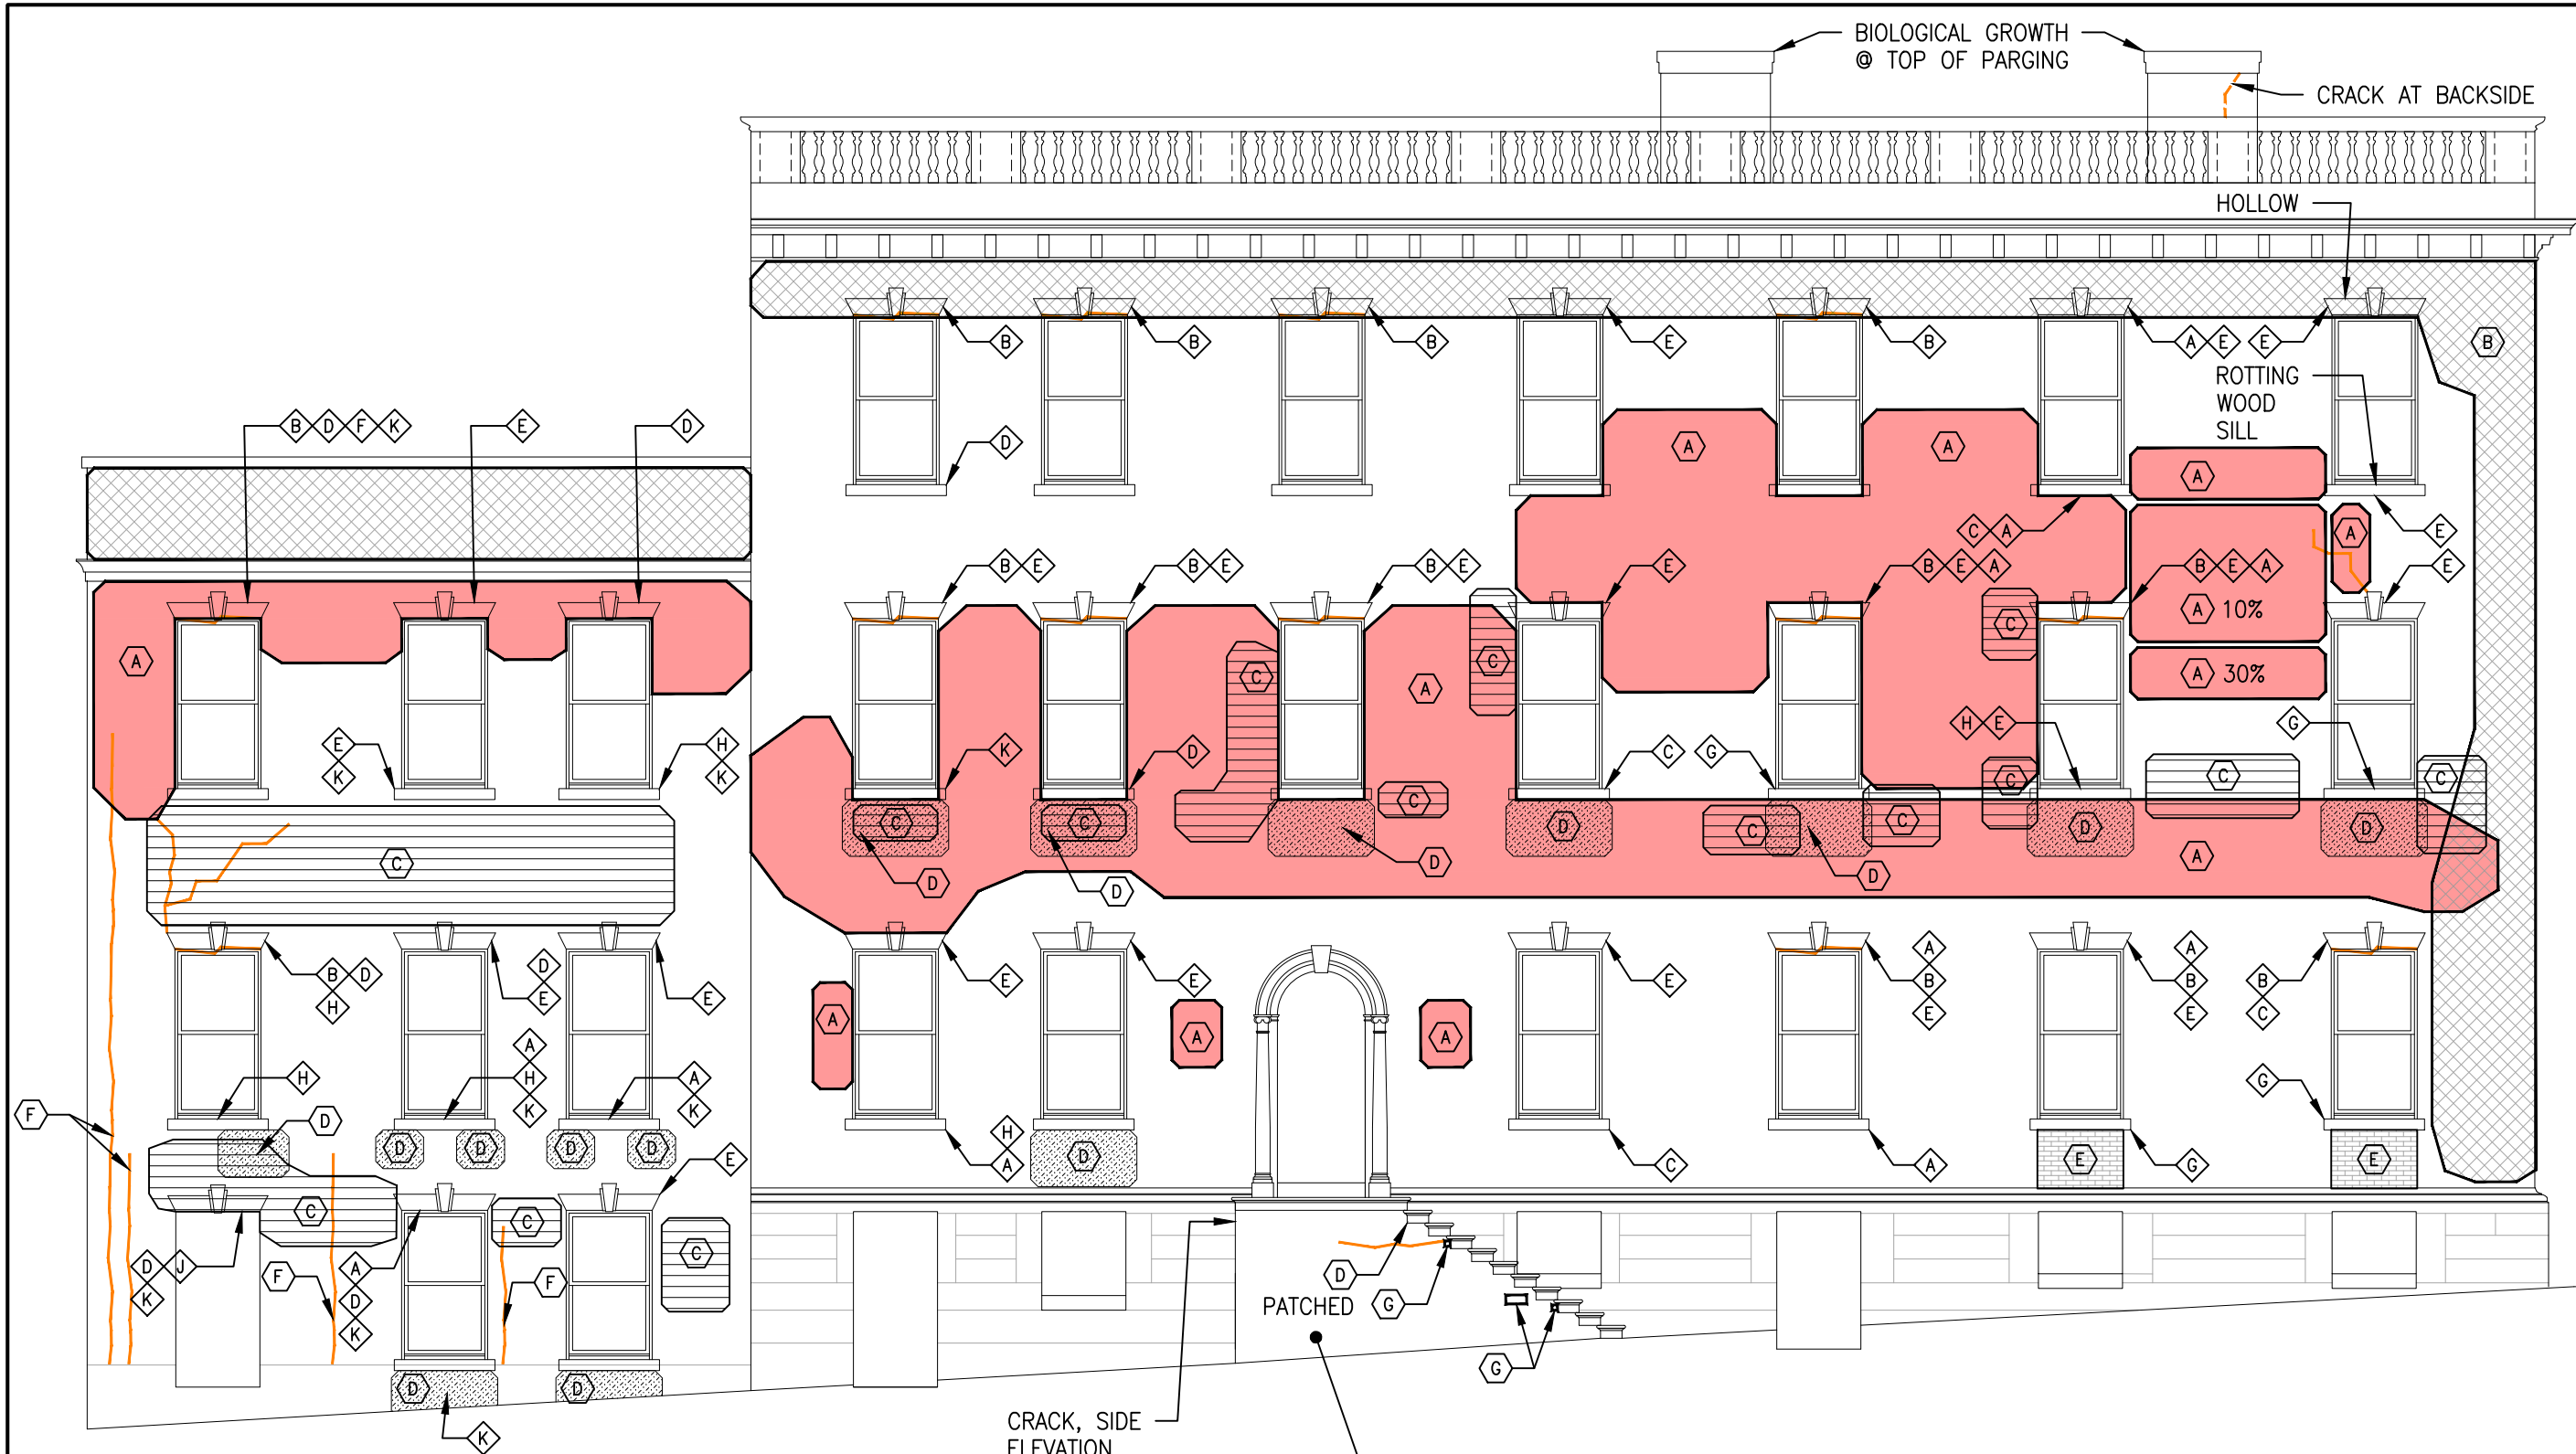
1  
S201

CRACK, SIDE  
ELEVATION

NOTE: STAIR BASE AT NORTH  
ELEVATION IS PARGED/STUCCO  
SURFACE AND BUILT OUT  
FROM ORIGINAL STONE.  
BIOLOGICAL GROWTH/STAINING,  
TYP.
